West Boulevard Properties Facility Conditions Report

March 17, 2022

Re: 1533 West Boulevard  
Charlotte, NC  
High Level Structural Existing Conditions Assessment

### INFRASTRUCTURE ASSESSMENT REPORT

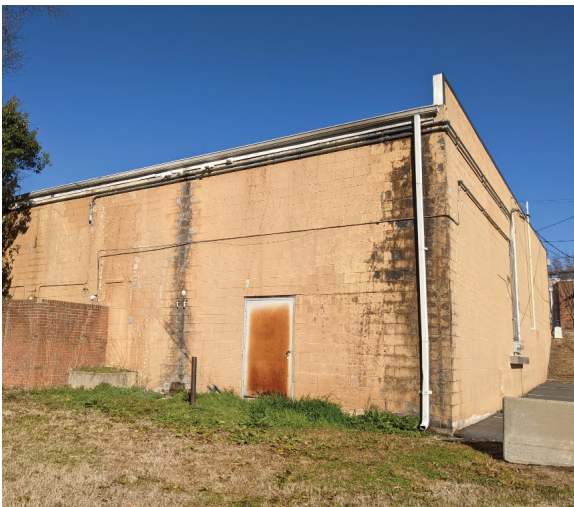
Along the backside of the building there were signs of water stains from gutter and downspouts not functioning properly. This could be an indicator of water infiltration through the wall or roof assemblies that can further compromise the architecture and the health and safety of the public. Further investigation would need to be performed to determine the extent of impact at these instances.

Water stained exterior

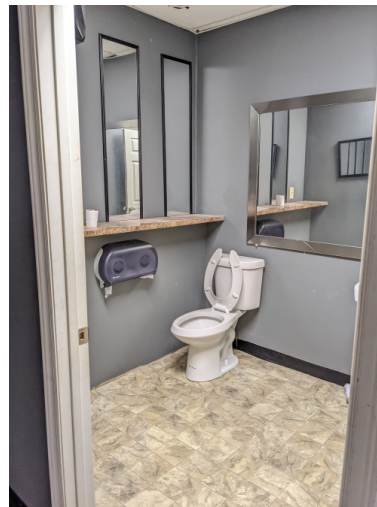
Toilet facilities, though appearing to be functional, were for the most part non-compliant with accessibility requirements of current code. A full building code assessment would need to be performed to assess what upgrades would be necessary, but generally it is obvious that many or all of these suites would need some level of renovation. The North Carolina Existing Building Code stipulates that for any renovations reconfiguring space, accessibility upgrades are required for up to 20% of the construction value. There may also be triggers associated with the sale of the building, or should there be a Change of Use from Retail that may require full compliance rather than 20% upgrades.

Inaccessible toilet room

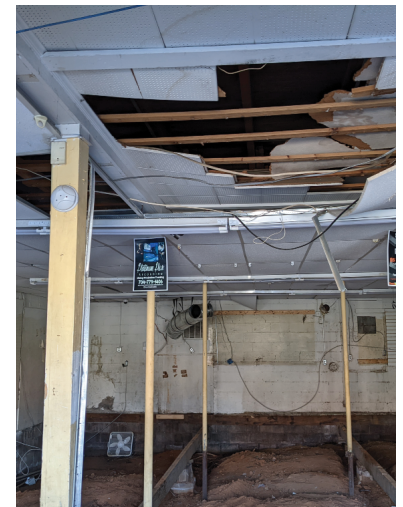
Unoccupied suite

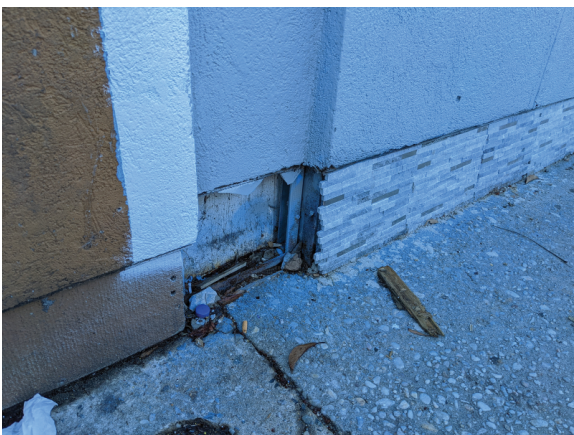
1. Exterior walls along the frontage is made up of stucco finish and aluminum framed glazed entries. Perimeter walls elsewhere was constructed of painted concrete masonry units (CMU). The wall condition showed signs of age with some settlement cracks in the CMU and unfinished or compromised edges of the stucco finish in several instances. There were signs of attempted refinishing to the storefronts, but only surface level. The wall assembly, flashings and closure at corners and transitions are in need of attention to address water and thermal barriers.

Compromised exterior envelope

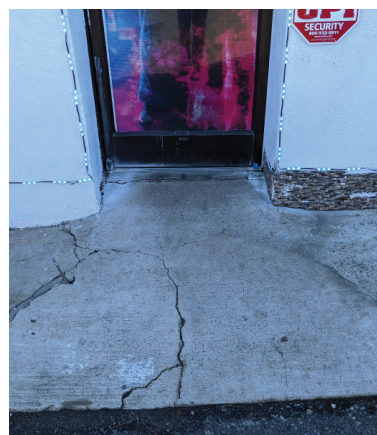
2. Patron access into the storefronts were consistent with the age of this building, as evidenced by the cracked and broken up concrete paving, recessed doorways and in some cases narrow door widths. These conditions do not meet current code requirements for accessibility. Further investigation would need to be performed to determine whether or not the occupant load of each suite is being properly served for exiting purposes.

Inaccessible entrance

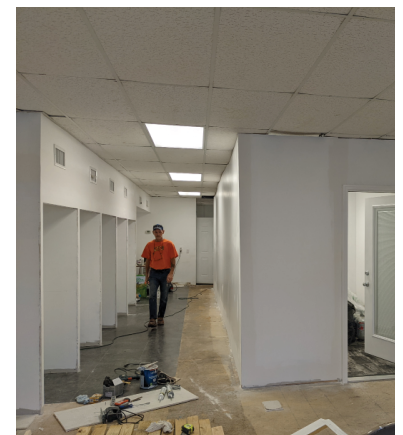
Suite under renovation

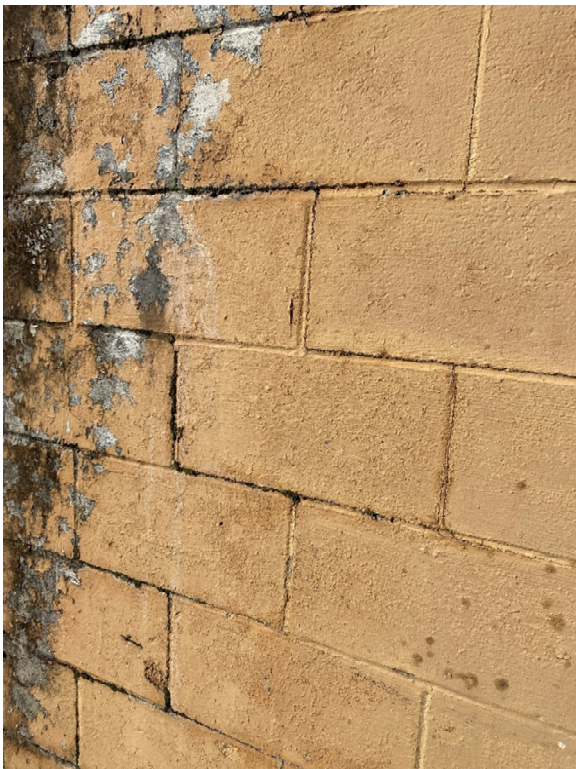
We walked the perimeter of the building looking for distress in the exterior walls. There were some cracks evident throughout the building, but none were a structural concern. The cracks appeared to be caused by shrinkage and minor settling of the building over time. Reuse construction of the building should include pointing the masonry walls to ensure long term structural integrity and a dry building envelope. The front of the building was covered and should be reviewed around lintels and supports to ensure there is not excessive cracking in those areas. We did not notice any movement or areas of concern during our visit.

Picture #3 – Minor Cracking

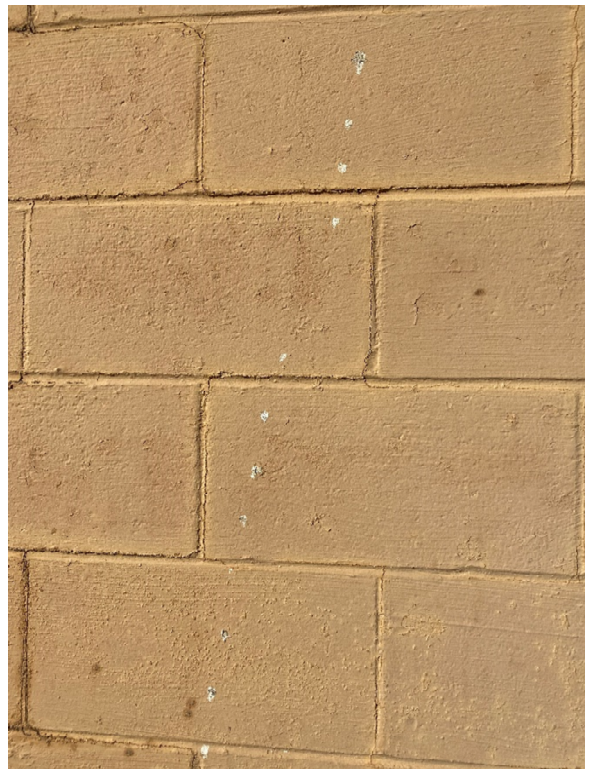
Picture #4 – Minor Cracking

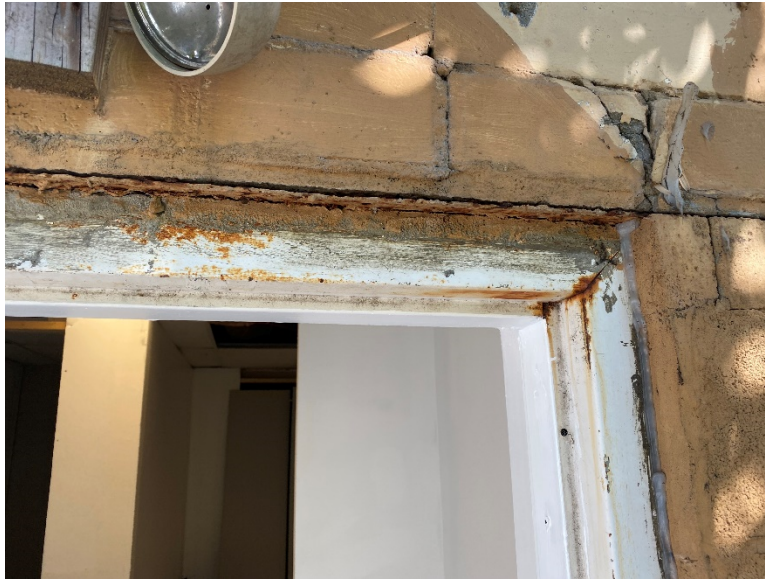
Picture #5 – Lintel Rust and Cracks

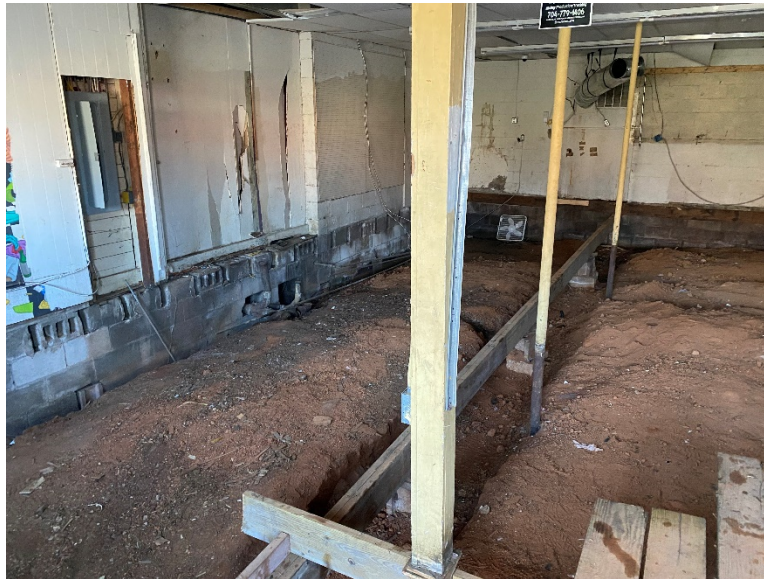
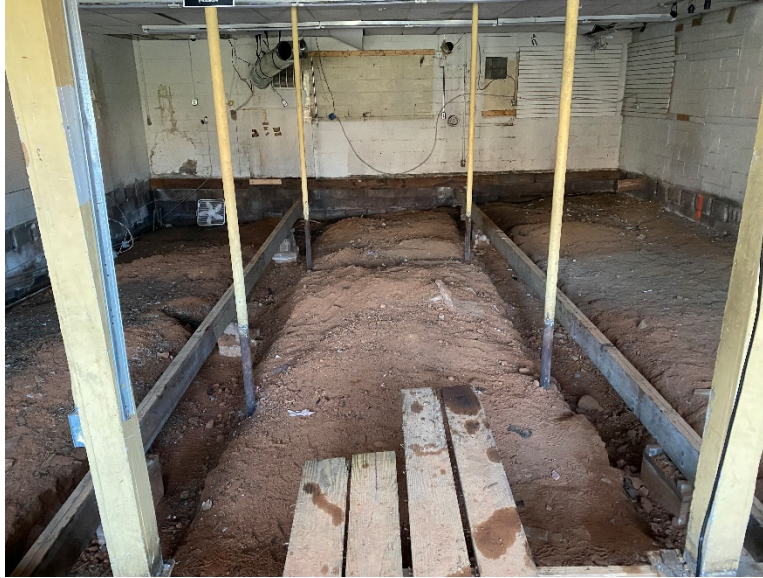
The middle third of the building had a crawl space structure. One of the units had the floor joists removed exposing the supporting beams, posts and piers. It was very evident that water intrusion had occurred at the floor and below level. The foundation walls were wet and the soil in the crawl space was damp. It didn't appear that the water was leaking in through the roof which means the water was coming from below and through the foundation walls.

The eastern third of the building had a basement structure due to the grade drop. We believe this area and the remaining area of floor over the crawl space were exposed to water and did not have enough ventilation. As we walked the spaces it was evident that the floors were very uneven, warped and deflected.

Picture 8 – Crawl Space with Removed Floor

Picture #9 – Crawl Space with Removed Floor

Any reuse of this building would require replacement of all of the elevated floor structure throughout the building. When that repair occurs the water and ventilation issue will need to be resolved to prevent damage in the future.

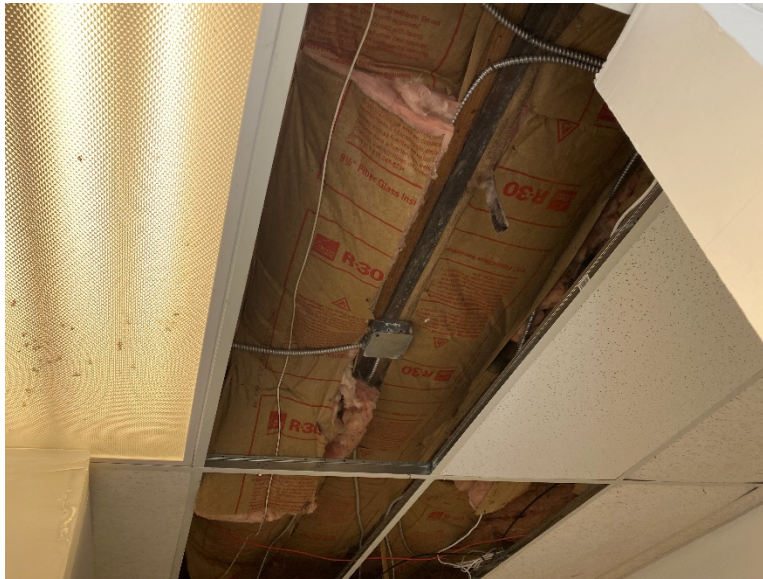
As described above, the roof structure of the large building consisted of plywood sheathing spanning between roof joists. The roof joists which were exposed appeared to be sound and free of any damage. The ceilings covering the joists did not exhibit excessive water damage. The steel and wood beams supporting the joists in the interior of the building did not show any signs of distress or water damage. We didn't notice any areas of excessive deflections. Overall, the roof structure appeared to be in good condition.

Picture #10 – Roof Structure

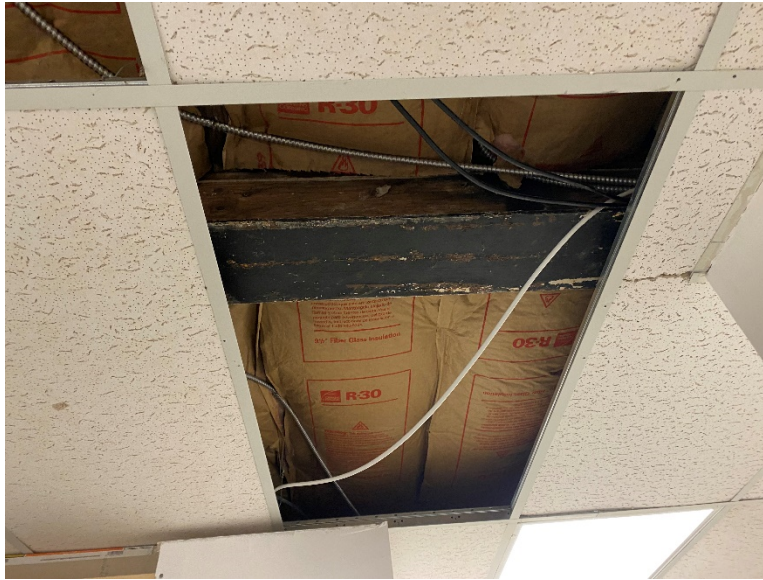
Picture #11 – Roof Beam Supporting Roof Joists
