Geotechnical Data Report

Vest to Franklin Force Main Charlotte, North Carolina

April 4, 2023 Terracon Project No. 71225194

Charlotte Water Charlotte, North Carolina

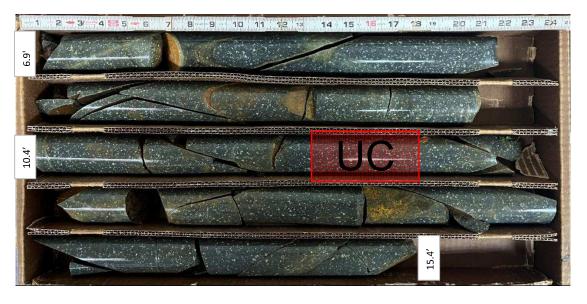
Site Description: Charlotte, NC	County: Mecklenburg	Boring Location: BH-12B (1 of 2)
Driller: J. Cain	Core Size: NQ	Drill Machine: CME-550x
Geologist / Engineer: F. Brock	Total Core Length: 28.3 feet	Date: 10/28/2022

R-1 and R-2: Run 1: 6.9' to 10.4' and Run 2: 10.4' to 15.4'

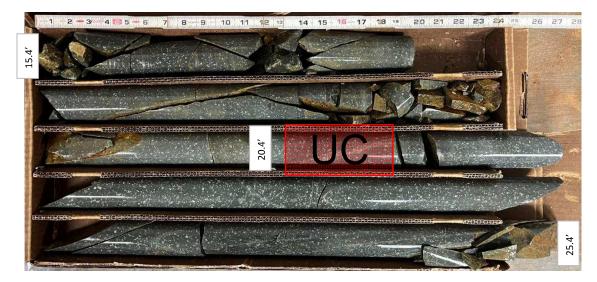
R-3 and R-4: Run 3: 15.4' to 20.4' and Run 4: 20.4' to 25.4'

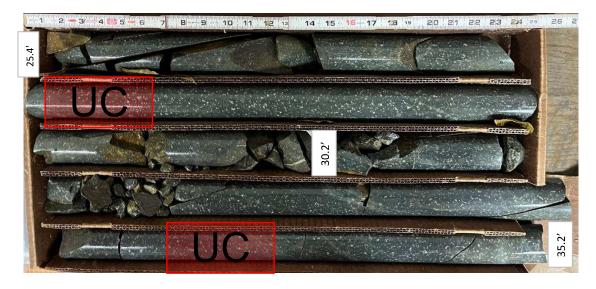
Site Description: Charlotte, NC	County: Mecklenburg	Boring Location: BH-12B (2 of 2)
Driller: J. Cain	Core Size: NQ	Drill Machine: CME-550x
Geologist / Engineer: F. Brock	Total Core Length: 28.3 feet	Date: 10/28/2022

R-5 and R-6: Run 5: 25.4' to 30.2' and Run 6: 30.2' to 35.2'

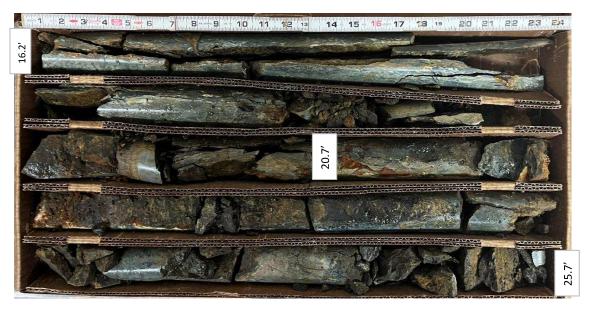
Site Description: Charlotte, NC	County: Mecklenburg	Boring Location: BH-13 (1 of 1)
Driller: J. Cain	Core Size: NQ	Drill Machine: CME-550x
Geologist / Engineer: M. Bovenzi	Total Core Length: 19.5 feet	Date: 10/24/2022

R-1 and R-2: Run 1: 16.2' to 20.7' and Run 2: 20.7' to 25.7'

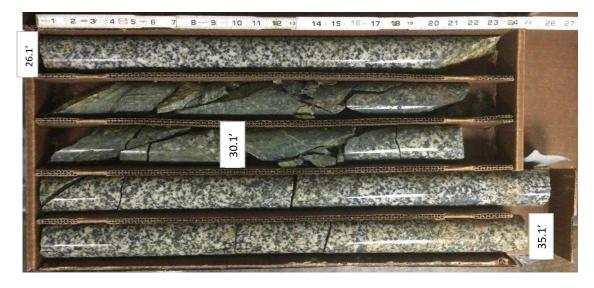
Site Description: Charlotte, NC	County: Mecklenburg	Boring Location: BH-14 (1 of 1)
Driller: J. Cain	Core Size: NQ	Drill Machine: CME-550x
Geologist / Engineer: F. Brock	Total Core Length: 9.0 feet	Date: 10/21/2022

R-1 and R-2: Run 1: 26.1' to 30.1' and Run 2: 30.1' to 35.1'

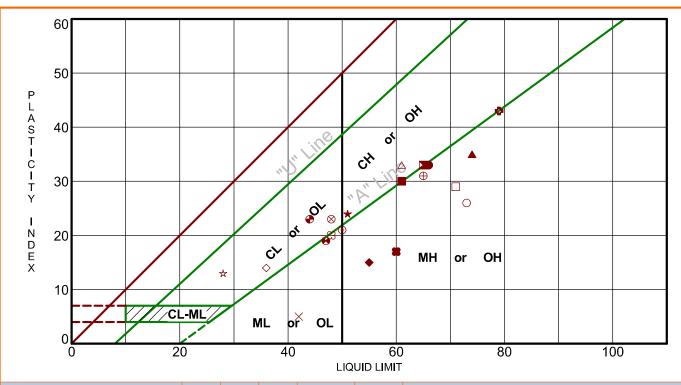
ATTERBERG LIMITS RESULTS

ATTERBERG LIMITS 71225194 VEST TO FRANKLIN FORCE MAIN.GPJ TERRACON_DATATEMPLATE.GDT 2/8/23		N 20 E X 10	///cL	-ML	*	JL oi	OL	60	
) TERR	Во	ring ID	Depth (Ft)	LL	PL	PI	Fines	USCS	Description
IN.GP.	•	BH-01	3.5 - 5	66	33	33	74.2	MH	ELASTIC SILT with SAND
CE MA		BH-02	1 - 2.5	65	32	33	84.5	СН	FAT CLAY with SAND
N FOR	A	BH-05	3.5 - 5	74	39	35	71.3	MH	ELASTIC SILT with SAND
SANKL	*	BH-09	6 - 7.5	51	27	24	55.6	СН	SANDY FAT CLAY
TO FF	•	BH-10	3.5 - 5	50	29	21	61.5	МН	SANDY ELASTIC SILT
4 VEST	۰	BH-11	5 - 7	79	36	43	83.9	МН	ELASTIC SILT with SAND
22519	0	BH-18	3.5 - 5	73	47	26	98.1	МН	ELASTIC SILT
ITS 71	Δ	BH-19	2 - 4	61	28	33	81.0	СН	FAT CLAY with SAND
3G LIM	\otimes	BH-20	1.8 - 3.8	48	25	23	75.4	CL	LEAN CLAY with SAND
ERBEF	Φ	BH-20.5	10 - 12	65	34	31	76.3	МН	ELASTIC SILT with SAND

- 1		BH-23	3.5 - 5	71	42	29	96.3	MH	ELASTIC SILT
PORT	•	BH-25	6 - 7.5	47	28	19	76.3	ML	SILT with SAND
AL RE	•	BH-28	1 - 2.5	44	21	23	62.1	CL	SANDY LEAN CLAY
SEPARATED FROM ORIGINAL REPORT.	☆	BH-30	3.5 - 5	28	15	13	49.6	SC	CLAYEY SAND
ROM (ස	BH-34	1 - 2.5	48	28	20	69.8	ML	SANDY SILT
ATED F		BH-35	3.5 - 5	61	31	30	68.0	СН	SANDY FAT CLAY
EPAR,	•	BH-36	8.5 - 10	55	40	15	95.6	MH	ELASTIC SILT
	\Diamond	BH-39	3.5 - 5	36	22	14	51.8	CL	SANDY LEAN CLAY
OT VAL	×	BH-40	3.5 - 5	42	37	5	53.1	ML	SANDY SILT
NRE NC	*	BH-46	6 - 7.5	60	43	17	84.9	MH	ELASTIC SILT with SAND
LABORATORY TESTS ARE NOT VALID IF	PF	ROJECT: Vest to	Franklin Force M	⁄lain		7	er:	acc	PROJECT NUMBER: 71225194
LABORATO	SITE: 820 Beatties Ford Road Charlotte, NC					2701 Westport Rd Charlotte, NC			CLIENT: Charlotte Water Charlotte, NC

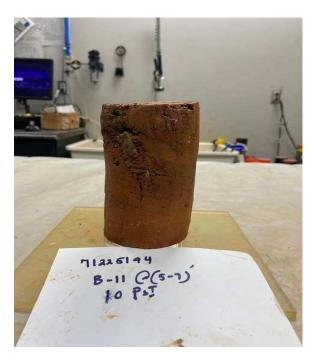
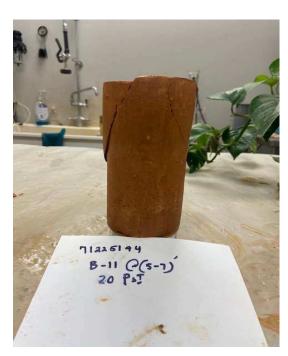
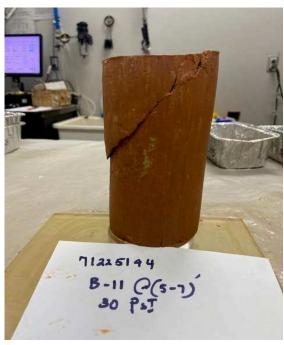
Specimen Failure Illustration

Sample No.		1	2	3	
3	Initial	Water Content, % Dry Density, pcf Saturation, % Void Ratio Diameter, in. Height, in.	40.6 85.1 109.8 1.0166 2.865 5.799			
2	At Test	Water Content, % Dry Density, pcf Saturation, % Void Ratio Diameter, in. Height, in.	41.1 85.1 111.2 1.0166 2.865 5.799	47.0 74.1 99.5 1.2742 2.865 5.996	78.3 100.1 1.1528	
	Str	ain rate, in./min.	1.000	1.000	1.000	
	Ва	ck Pressure, psi	0.0	0.0	0.0	
	Се	II Pressure, psi	9.9	19.8	29.8	
	Fai	il. Stress, psi	38.4	46.9	50.8	
	Ult	. Stress, psi				
	σ₁ Failure, psi		48.3	66.8	80.5	
	σ_3	Failure, psi	9.9	19.8	29.8

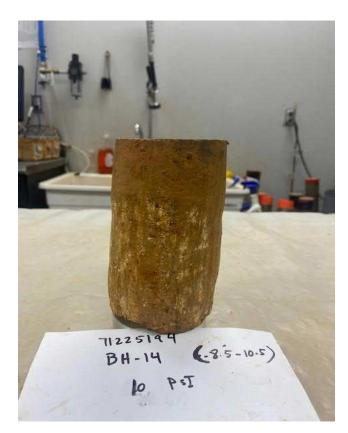
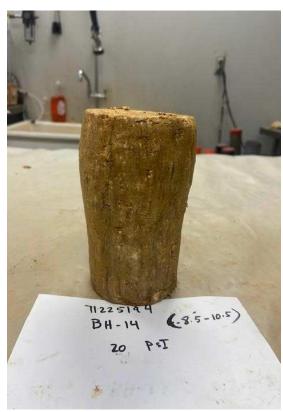
Specimen Failure Illustration

Sa	mple No.	1	2	3	
3	Initial	Water Content, % Dry Density, pcf Saturation, % Void Ratio Diameter, in.	20.7 99.5 80.6 0.6942 2.863	2.862	96.4 83.8 0.7481 2.863	
		Height, in.	5.878	5.902	5.865	
1	əst	Water Content, % Dry Density, pcf	22.6 99.5 87.8	23.2 95.6 82.3	96.4	
	At Test	Saturation, % Void Ratio Diameter, in. Height, in.	0.6942 2.863 5.878	0.7628	0.7481 2.863	
	Strain rate, %/min. Back Pressure, psi		1.00	1.00	1.00	
			0.0	0.0	0.0	
	Се	II Pressure, psi	10.0	20.0	29.9	
	Fail. Stress, psi		28.3	41.1	50.2	
	Ult	. Stress, psi				
	σ_1	Failure, psi	38.2	61.1	80.2	
	σ_3	Failure, psi	10.0	20.0	29.9

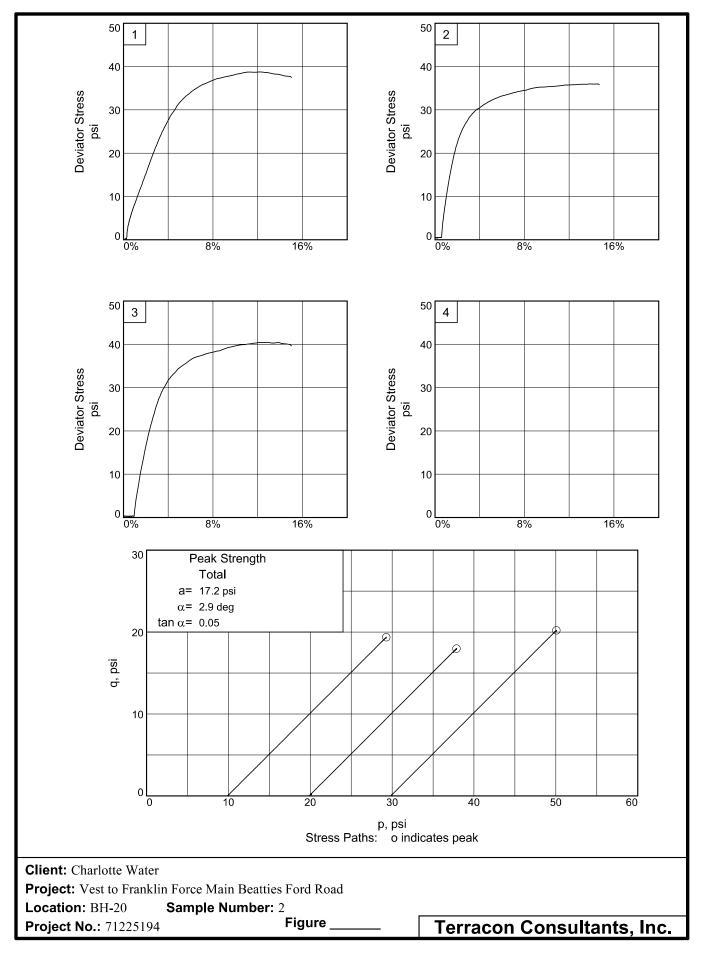
Figure BH-20

Sample No.		1	2	3	
312	Initial	Water Content, % Dry Density, pcf Saturation, % Void Ratio Diameter, in. Height, in.	26.2 94.7 90.7 0.7803 2.863 5.888		89.2 0.9083 2.862	
	At Test	Water Content, % Dry Density, pcf Saturation, % Void Ratio Diameter, in. Height, in.	25.7 94.7 89.0 0.7803 2.863 5.888	30.6 87.2 88.5 0.9326	30.4 88.3 90.4 0.9083 2.862	
	Str	ain rate, %/min.	1.00	1.00	1.00	
	Ва	ck Pressure, psi	0.0	0.0	0.0	
	Се	II Pressure, psi	9.9	19.9	29.8	
	Fail. Stress, psi		38.7	36.0	40.4	
	Ult	. Stress, psi				
	σ_1	Failure, psi	48.7	55.8	70.3	
σ ₂ Failure. psi		9.9	19.9	29.8

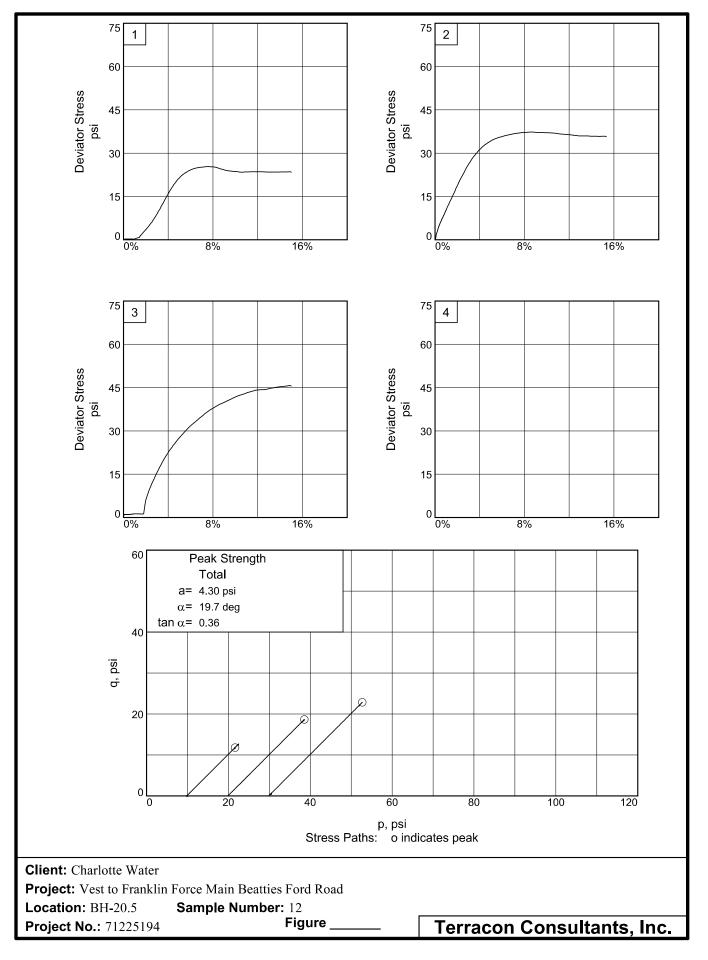
Figure BH-20.5

Sa	mple No.	1	2	3	
3	Initial	Water Content, % Dry Density, pcf Saturation, % Void Ratio Diameter, in. Height, in.	30.6 80.0 74.6 1.1062 2.863 5.698	2.862	2.862	
1	At Test	Water Content, % Dry Density, pcf Saturation, % Void Ratio Diameter, in. Height, in.	31.9 80.0 77.8 1.1062 2.863 5.698			
	Strain rate, %/min. Back Pressure, psi Cell Pressure, psi Fail. Stress, psi		1.00	1.00	1.00	
			0.0	0.0	0.0	
			9.8	19.9	29.9	
			23.6	37.3	45.7	
	Ult	. Stress, psi				
σ₁ Failure, psi			33.4	57.2	75.6	
σ_3 Failure, psi			9.8	19.9	29.9

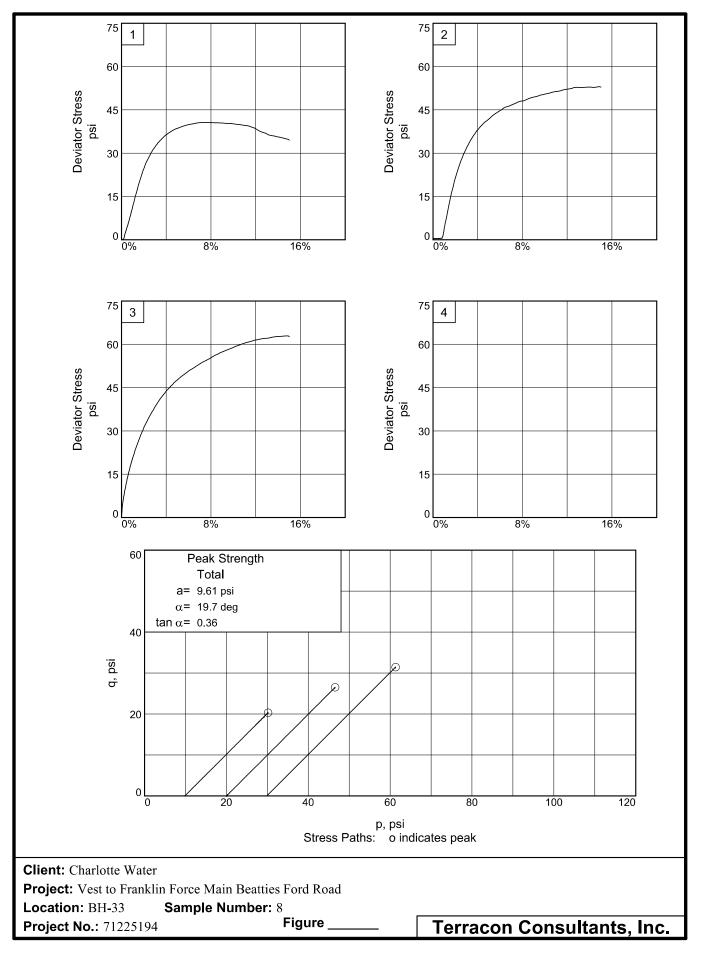
Figure Bh-33

Sa	mple No.	1	2	3	
3	Initial	Water Content, % Dry Density, pcf Saturation, % Void Ratio Diameter, in. Height, in.	18.1 83.1 47.5 1.0282 2.868 6.089	2.865	18.8 84.0 50.5 1.0069 2.862 6.005	
2	At Test	Water Content, % Dry Density, pcf Saturation, % Void Ratio Diameter, in. Height, in.	23.0 83.1 60.5 1.0282 2.868 6.089	18.8 77.5 43.1 1.1739 2.865 5.999	23.1 84.0 61.9 1.0069 2.862 6.005	
	Str	ain rate, %/min.	1.00	1.00	1.00	
	Ва	ck Pressure, psi	0.0	0.0	0.0	
	Се	II Pressure, psi	9.9	20.1	29.9	
	Fai	il. Stress, psi	40.6	53.0	62.9	
	Ult. Stress, psi					
	σ_1	Failure, psi	50.5	73.1	92.8	
	σ_3	Failure, psi	9.9	20.1	29.9

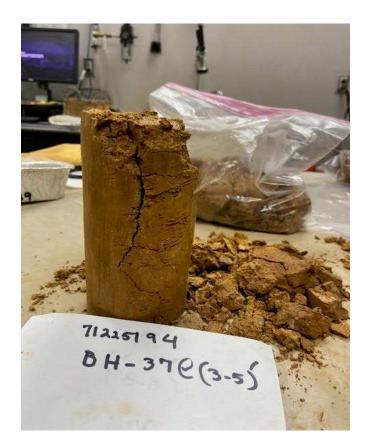
Specimen Failure Illustration

Laboratory test results unobtainable due to specimen collapse.

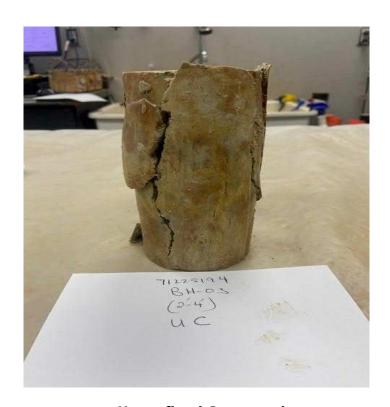
Specimen Failure Illustration

Unconfined Compression

Sample No.	1		
Unconfined strength, psi	17.06		
Undrained shear strength, psi	8.53		
Failure strain, %	3.1		
Strain rate, %/min.	1.00		
Water content, %	21.5		
Wet density, pcf	123.4		
Dry density, pcf	101.6		
Saturation, %	88.0		
Void ratio	0.6584		
Specimen diameter, in.	2.861		
Specimen height, in.	5.890		
Height/diameter ratio	2.06

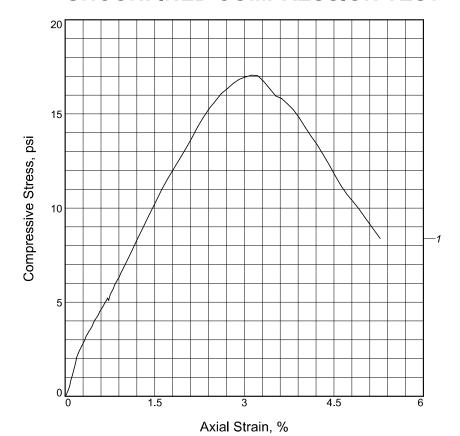
Description: Gray Fat CLAY with Sand-CH

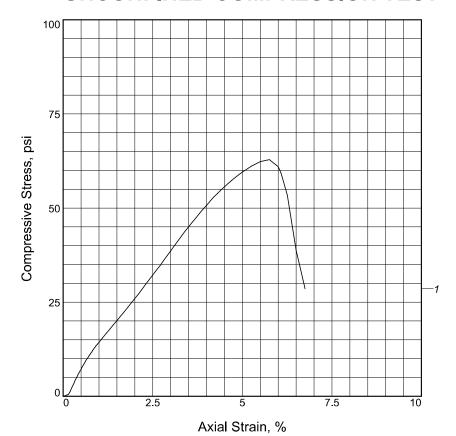
Figure BH-16 Terracon Consultants, Inc Charlotte, North Carolina

1		
62.85		
31.43		
5.8		
1.00		
25.2		
123.8		
98.9		
96.6		
0.7037		
2.853		
5.971		
2.09		
	31.43 5.8 1.00 25.2 123.8 98.9 96.6 0.7037 2.853 5.971	31.43 5.8 1.00 25.2 123.8 98.9 96.6 0.7037 2.853 5.971

Description: Red Fat CLAY with Sand- CH

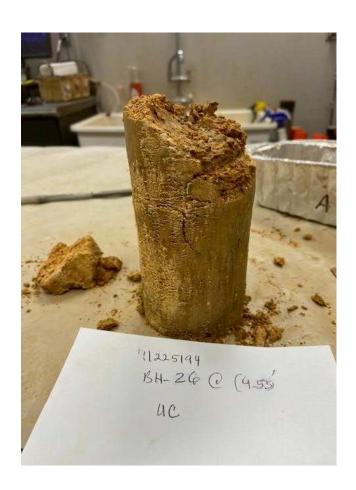
Specimen Failure Illustration

Unconfined Compression

Laboratory test results unobtainable due to specimen collapse.
