# **Repair or Replace Old Windows**

### A Visual Look at the Impacts

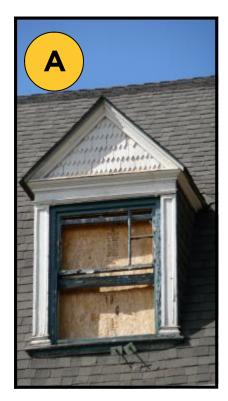
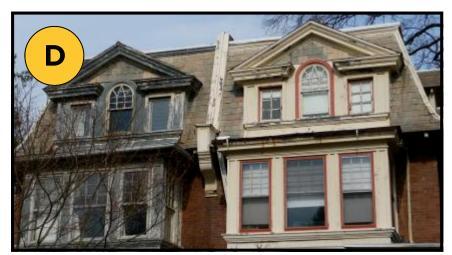
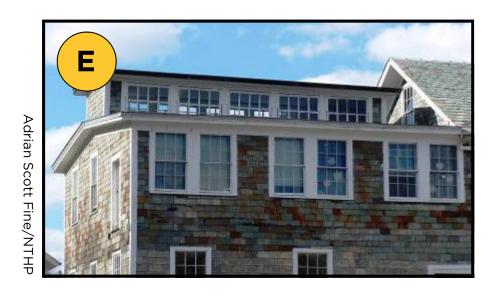
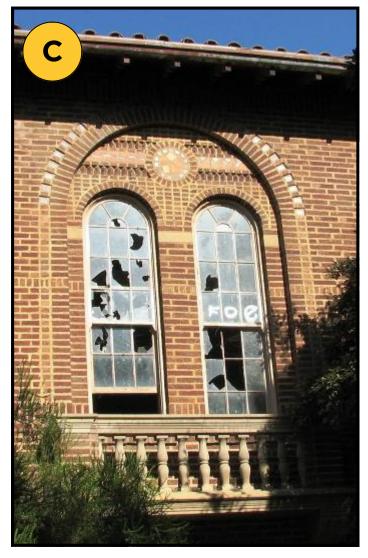
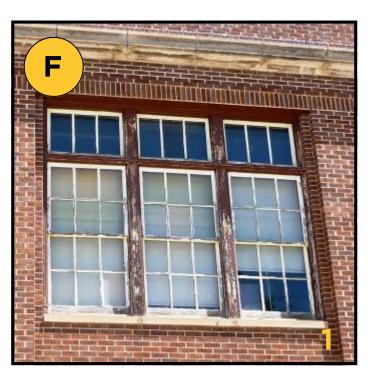
- A, B Two eight-over-eight double-hung sash dormer windows. Both are in disrepair; window A will need to be rebuilt or replaced to match window B.
- C Broken glass on these architecturally distinctive windows can be easily replaced and windows repaired.

- D A coat of paint and routine and preventive maintenance can restore windows to their original appearance.
- E Unique roof monitor with well-maintained and character defining six-over-six double-hung sash windows.

- F Group of six-over-six double-hung sash windows with transoms, only needing paint.

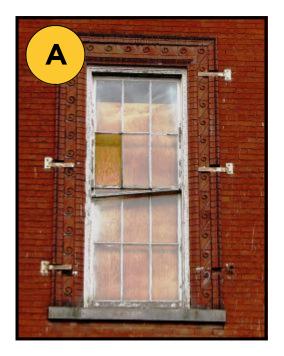
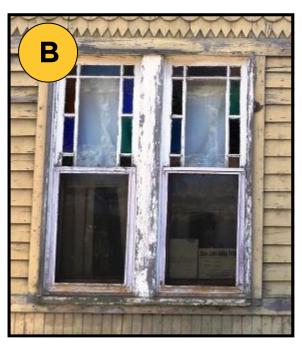
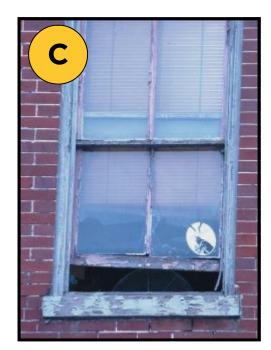
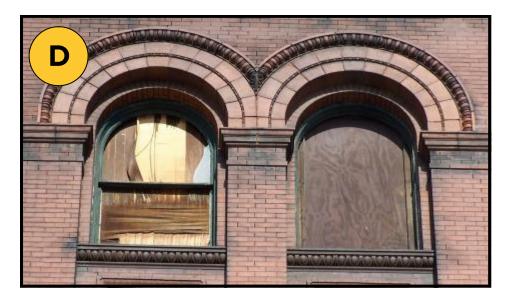
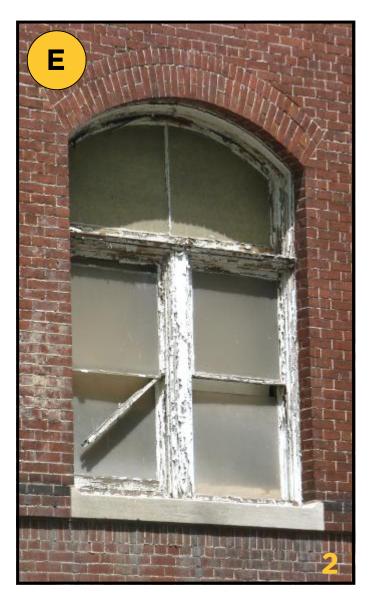
- A Six-over-six double-hung sash with loose meeting rail, missing glass can be repaired.
- B Queen Anne windows needing paint, re-glazing can be repaired.
- C Two-over-two double-hung sash with loose bottom rail, needing paint, re-glazing can be repaired.
- D Arched double-hung sash windows missing glass and frames replacement likely.
- E One-over-one double-hung sash windows and fixed transoms with detached meeting rail, needing paint and reglazing can be repaired.
- F Queen Anne window in poor condition, detached from frame and missing glass borderline, requiring extensive repairs.
- G Queen Anne window missing glass and subject to structural settling of the building borderline, requiring extensive repairs.

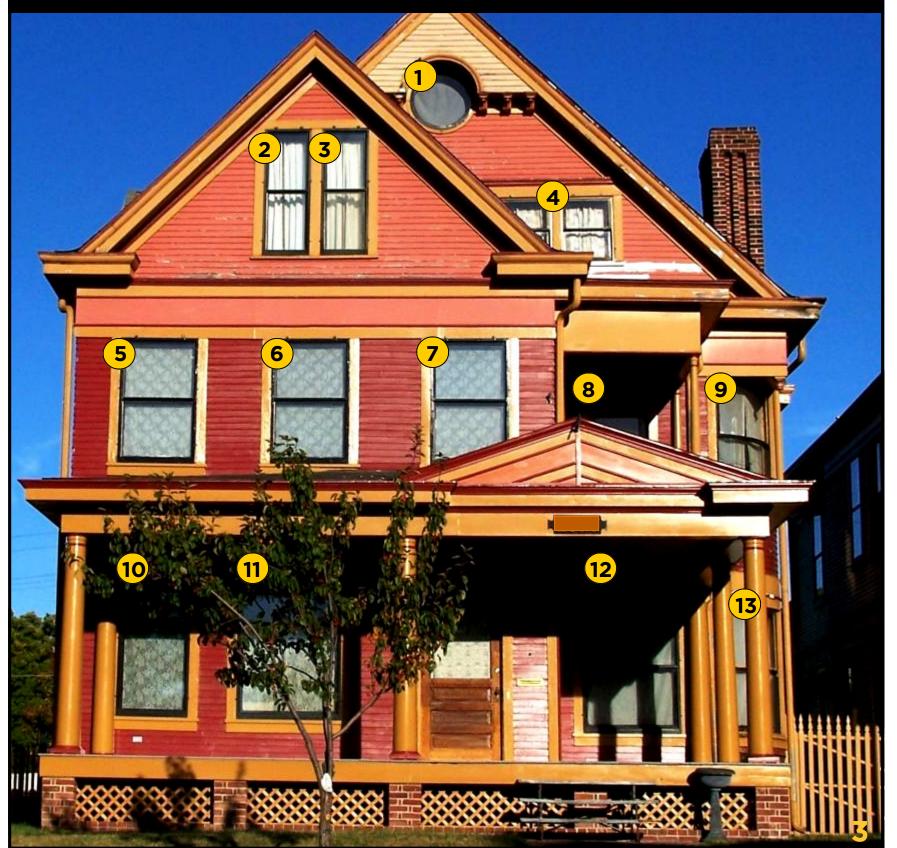
1890s Queen Anne style house Original one-over-one double-hung sash windows with storm windows

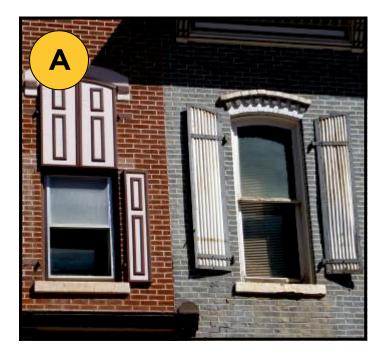
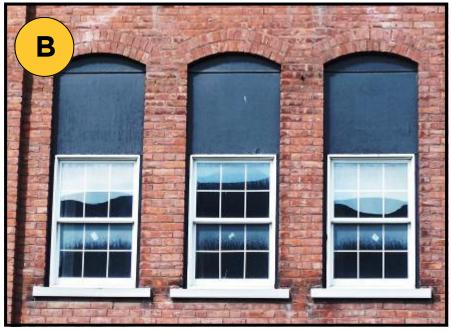
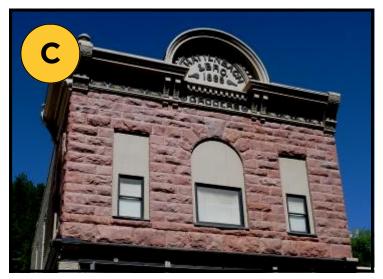
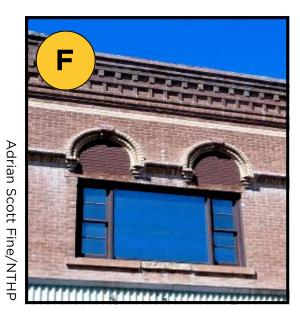
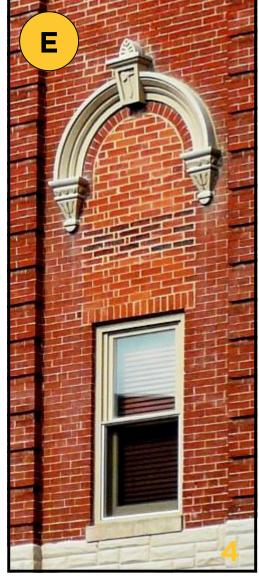
- A Italianate style row houses, side by side. Building to the right retains original arched one-over-one double-hung sash windows. Building to the left has smaller replacement windows and in-fill panels installed in the original opening.

- B Industrial building converted for housing with reduced windows and in-fill openings.
- C Main Street commercial building with upper floor windows removed, openings reduced down and much smaller replacement windows that do not match.

- D A stock, smaller window unit was used to replace a larger double-hung sash window.
- E Brick was used to in-fill the original opening of the round-arched window.

- F Two round arched windows were removed and replaced by one larger picture window, completely different in design and period to the historic Main Street building.

- G Three vertically-oriented Gothic style windows were reduced and replaced by horizontally-oriented hopper type windows.

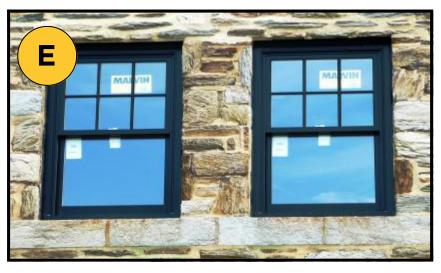
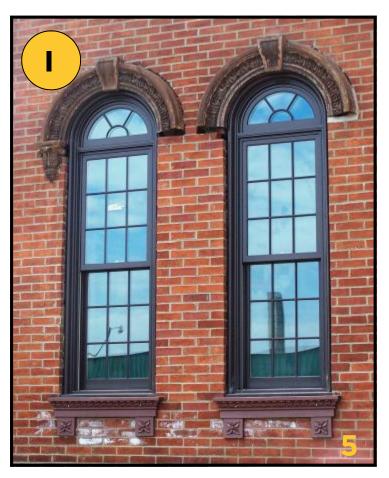
- A Replacing an original double-hung sash window with a casement and fixed transom dramatically changes the look and architectural character of this historic building.

- B Modern interpretation of an arched window alters the pattern and overall design on this monumental civic building. If original windows are no longer intact, this approach may be acceptable as windows clearly reflect their own era.

- C Replacing a round arched double-hung sash window is a one-over-one double-hung sash with fixed transom. This illustrates using stock windows to fit an opening that often requires a custom or more costly replacement window.

- D The thickness of muntins as well as their profile can make a difference. This window is not a true divided-light design, instead featuring applied, flat muntins.

- E New windows will often require 'building out' and enlarging the casing and surround to accommodate a stock replacement unit, effectively reducing the size of the window in comparison to the originals.

- F The introduction of a hopper window completely alters the look of this window.
- G, H Window G features the original twenty-over-twenty double -hung sash window. The replacement, window H, is a fixed one-over-one unit. The design, profile and depth are altered in the process.

- New windows attempt to replicate originals, though the casing and surround is wider and the fixed fanlight does not match originals.

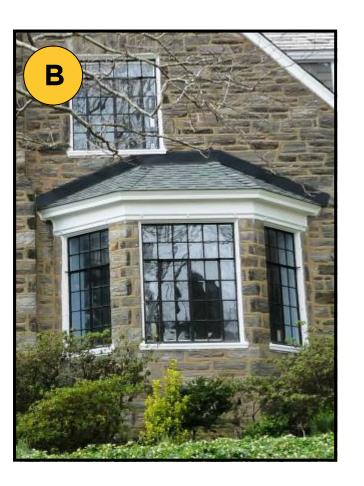
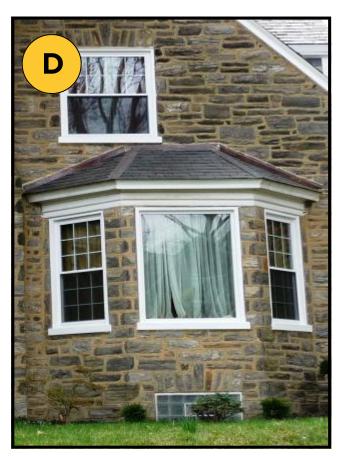
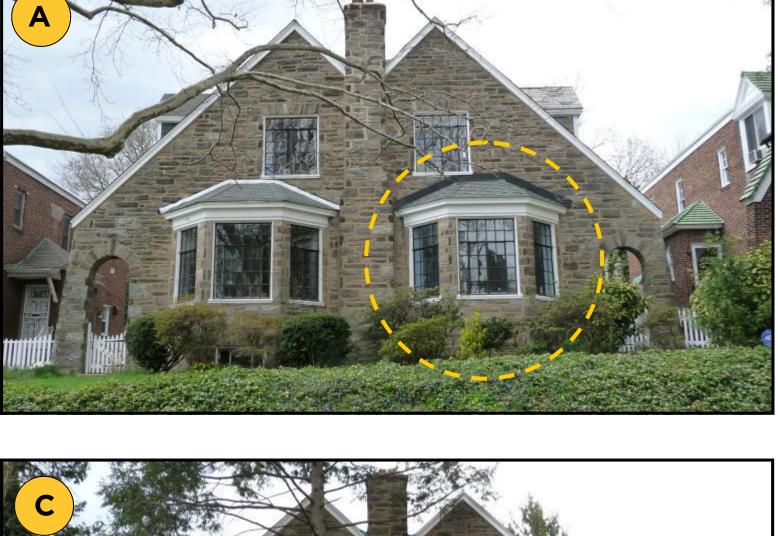
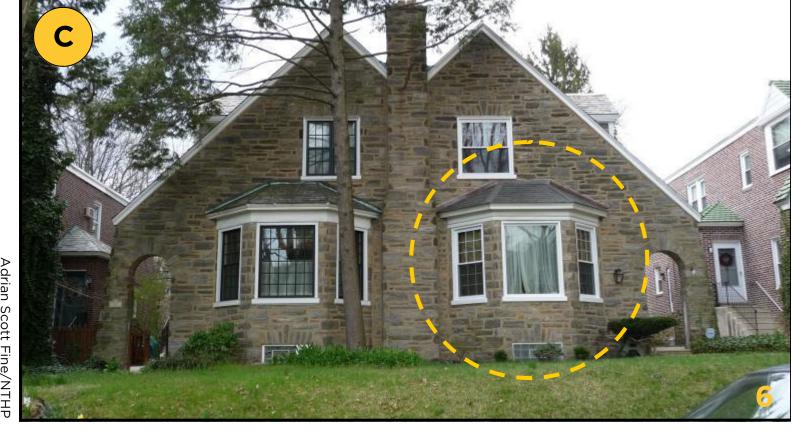
- A, B Both sides of this duplex feature original rolled steel casement windows with interior storm window inserts.
- C, D Both sides of this duplex have replacement windows. The one to the left more closely mimics the lines and details of the original steel casements, though the new windows are a mixture of fixed and double-hung sash units and the proportions are not an exact match. The unit to the right also features fixed and double-hung sash replacement windows. In this case, the result is less successful with white vinyl casing and a central picture window missing any muntin pattern.

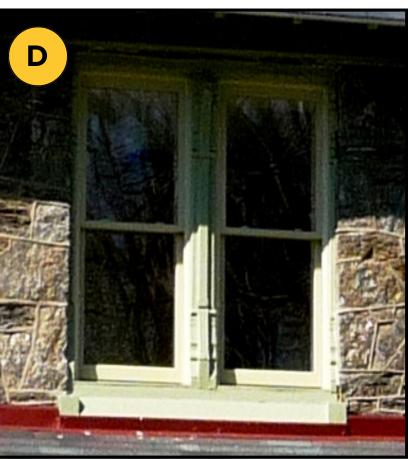
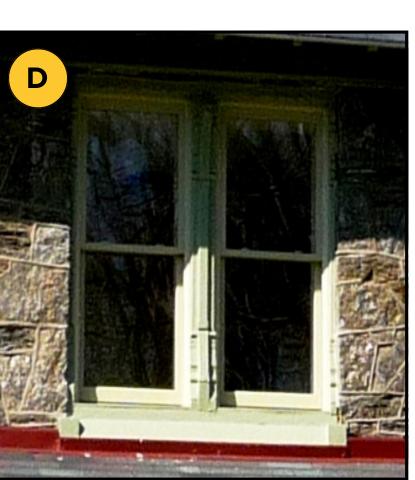
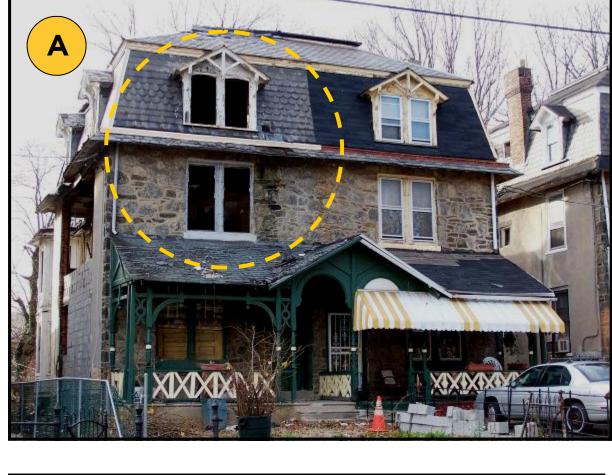
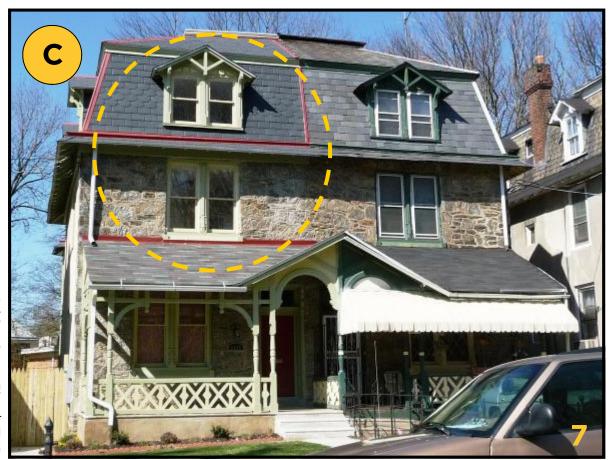
- A, B Original windows are missing but decorative casings and openings remain.
- C, D As part of the rehabilitation project, new wood double-hung sash windows were chosen to fit the original openings and the decorative casings were repaired and retained. New windows replicate the originals in terms of size, type, proportion and materials.

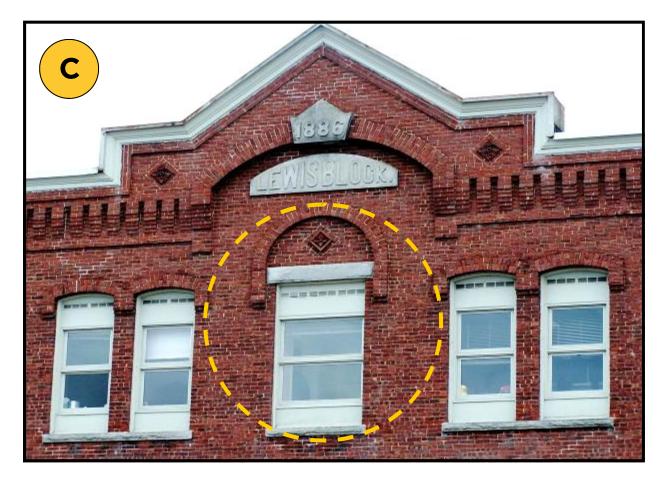
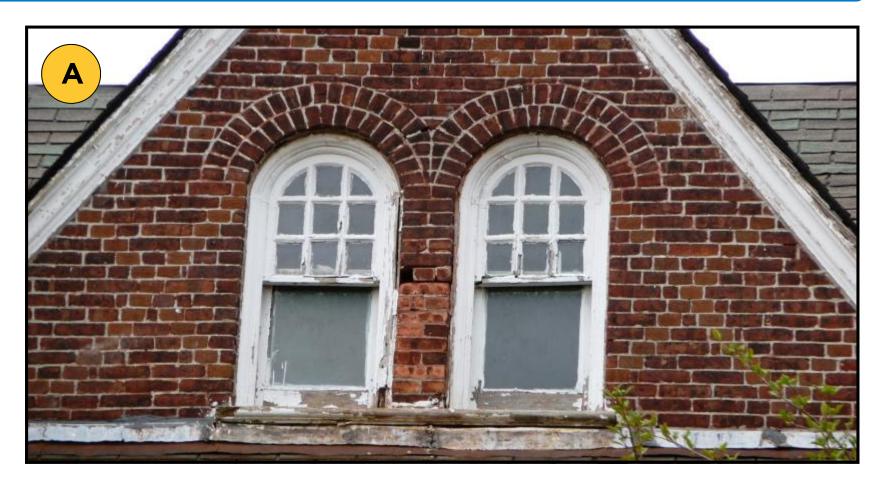
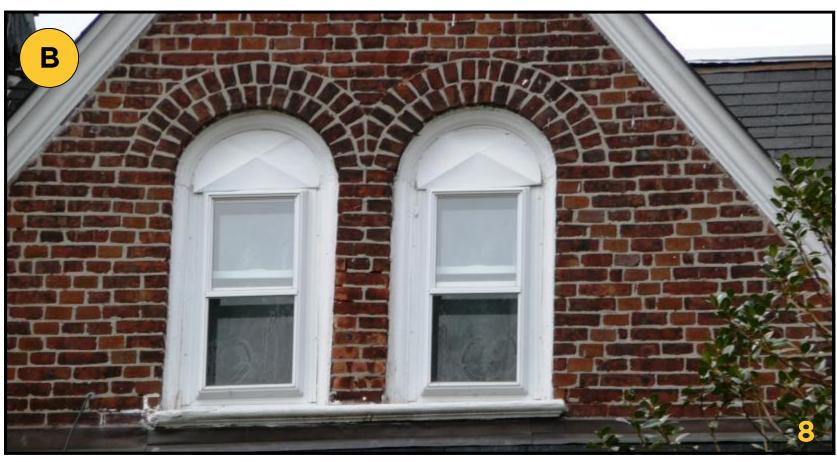
- A Two, arched nine-over-one double-hung sash windows are in disrepair with loose meeting rails and paint build up. They can be easily repaired and still maintain the character of the building.
- B An identical building with replacement windows. Stock units were used with aluminum in-fill around the opening. The difference in character between A and B is dramatic.
- C The upper story windows of this Main Street commercial structure were replaced with stock units with in-fill at the top and bottom.

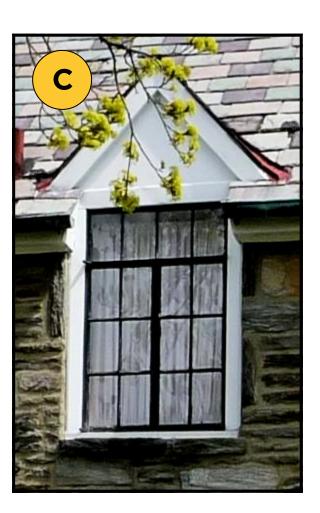
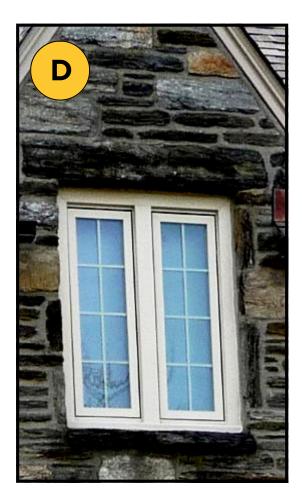
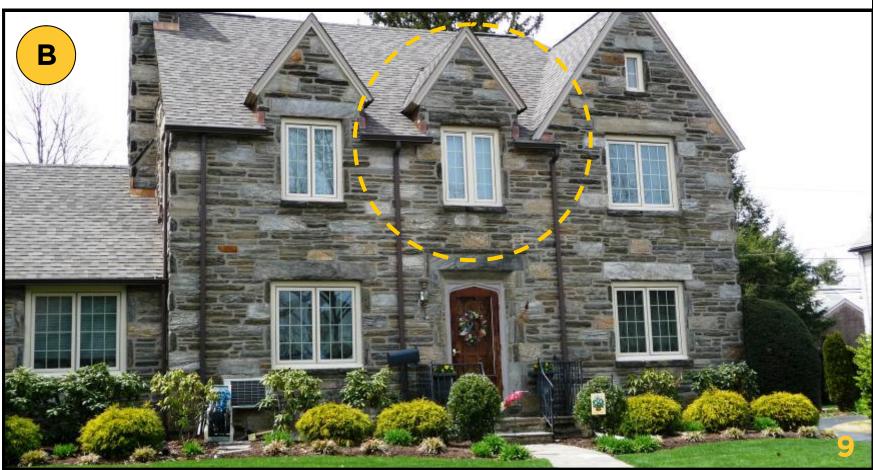
- A Steel casement windows with fixed transoms and sidelights, featuring interior storm windows. These windows are a character defining feature of the house.
- B Replacement windows attempt to match with casement style units yet the proportion, pattern, width and lack of a true divided-light miss the mark.
- C, D The differences between the original and replacement are readily seen, where the wider casing and surround are much prominent on the replacement windows.

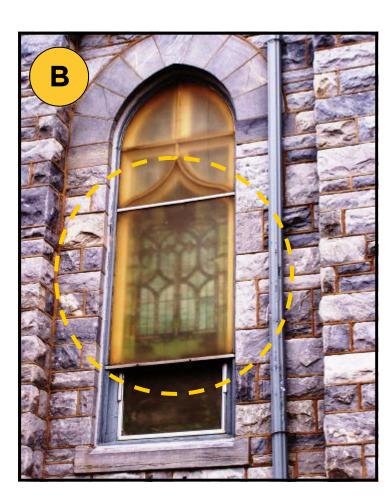
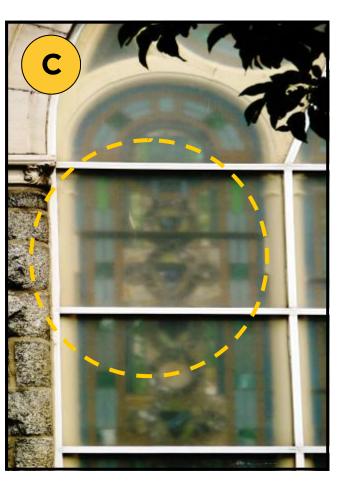
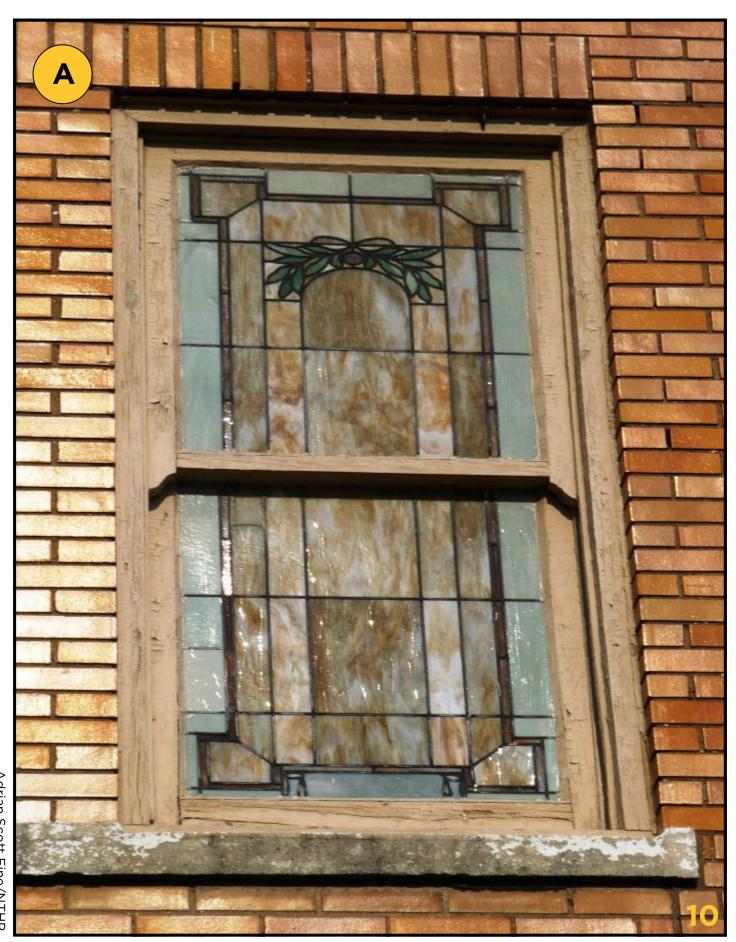
- A Exposed original one-over-one double-hung slag glass window.
- B Plastics (Lexan or Plexiglass) are impact-resistant and nearly shatterproof but tend to yellow and get hazy over time.
- C Windows are obscured and the pattern is dramatically altered with new aluminum rails as part of this protective glazing system.

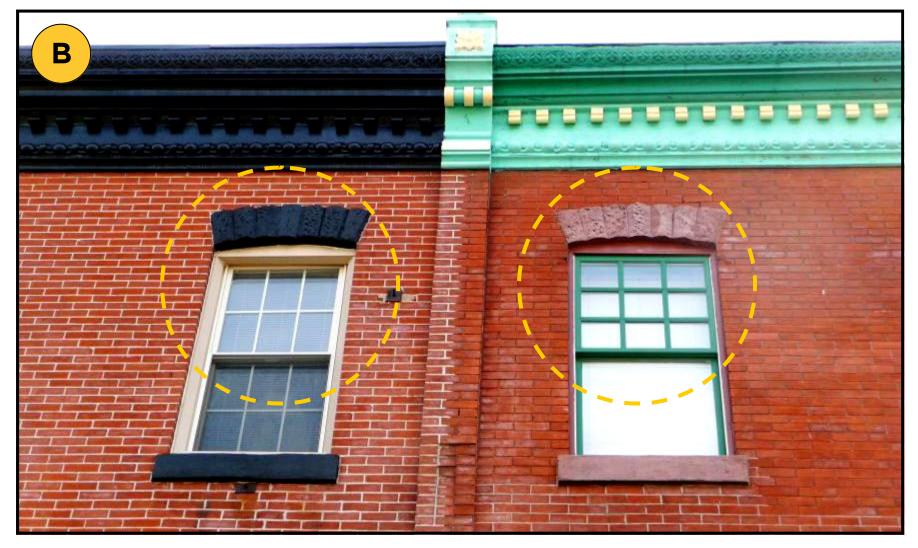
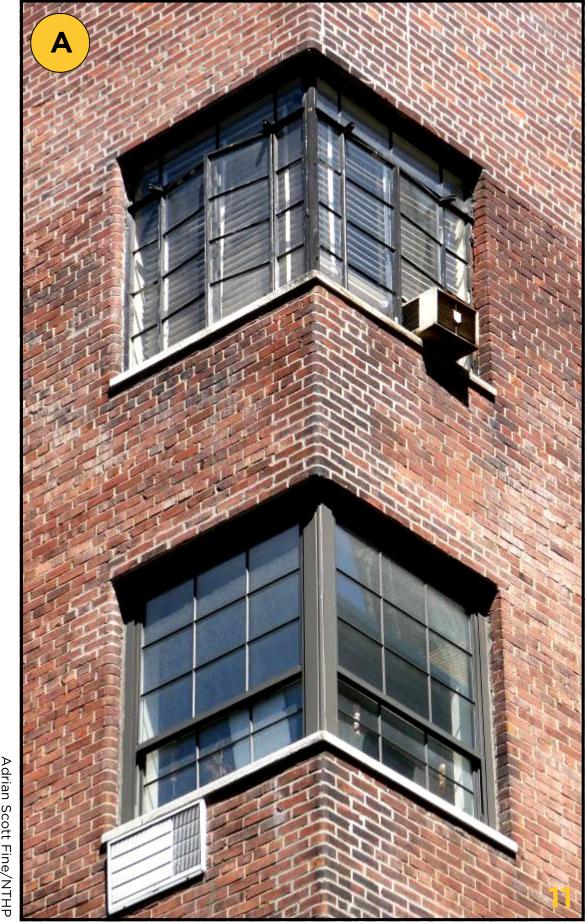
- An early 1940s apartment building designed in the Art Deco style features corner, steel casement windows. The slender profile of the muntins and casing is a character defining feature. The replacement double-hung sash window, at the bottom, attempts to match the lines of the original, yet the muntin pattern and width of casing are much different.
- Two double-hung sash replacement windows on side-by-side row houses demonstrate the subtle, but noticeable differences in design. While original windows were identical, these are different in terms of depth, muntin size and pattern and width of casing.

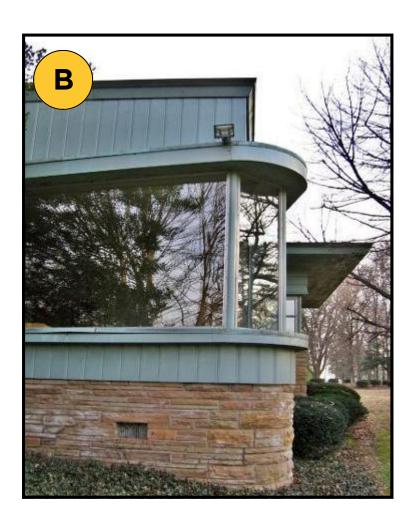
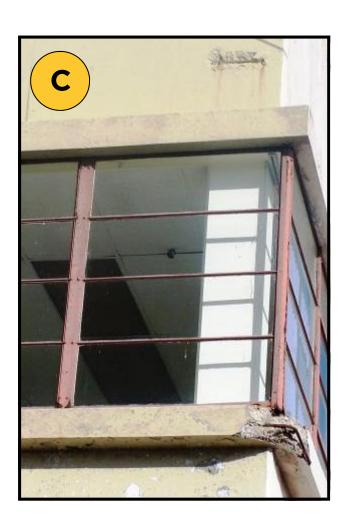
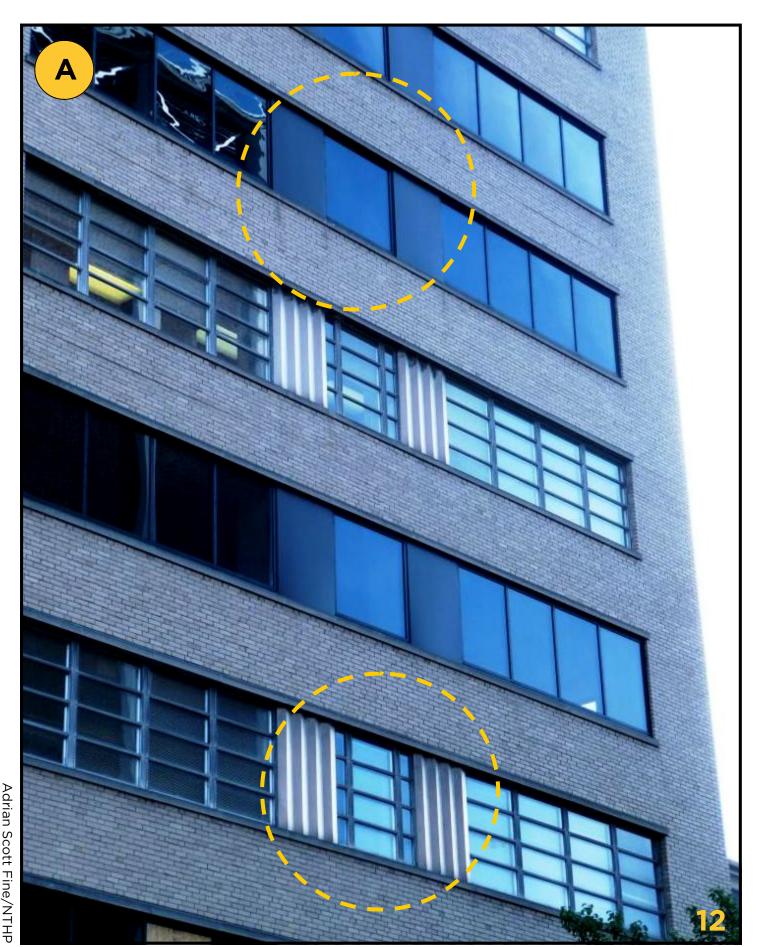
- A Original, character defining windows and corrugated stainless steel detail are being removed on this 1950s office building, replaced by dark tinted fixed windows that do not match.
- B, C Large spans of single pane and plate glass require innovative solutions, such as custom designed storm windows.

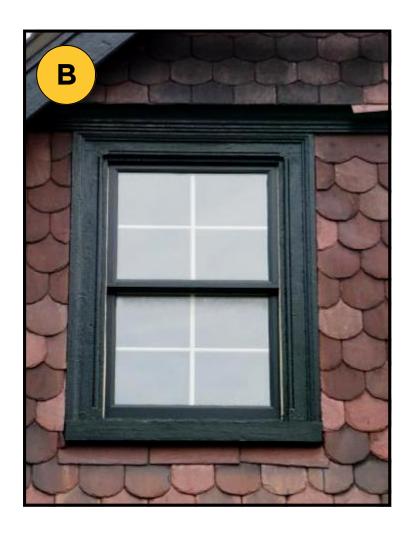
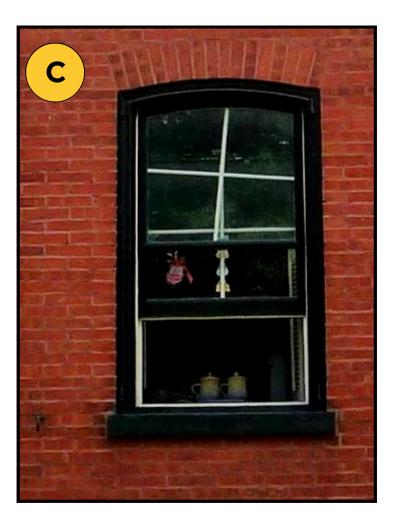
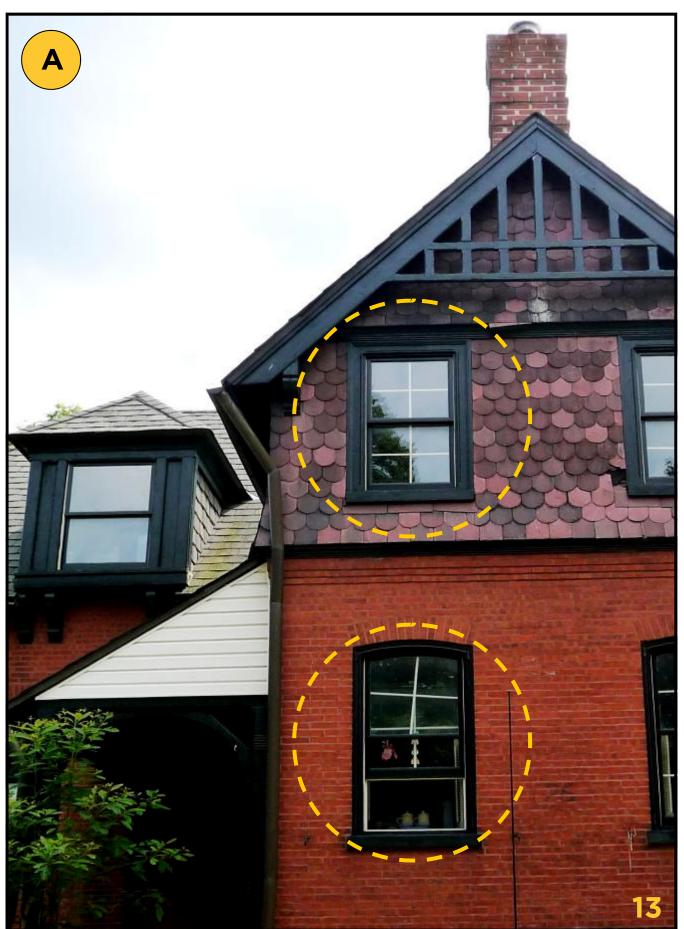
- A A former carriage house, rehabilitated and preserved for a new use, features replacement windows that attempt to look like true divided-light windows.
- B This four-over-four double-hung sash still has its original wood casing with a replacement window with clipped on interior muntins. There is little dimension or depth with this design and instead looks like a one-over-one sash.
- C This shows how clipped on interior muntins can loosen or fall off.

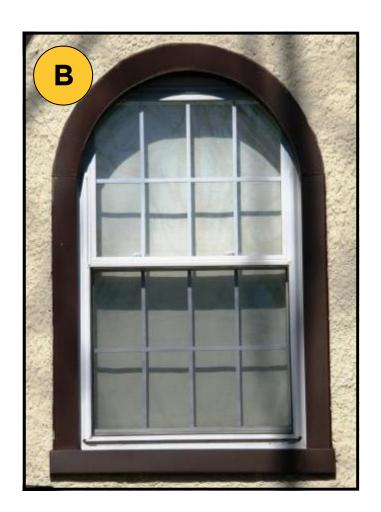
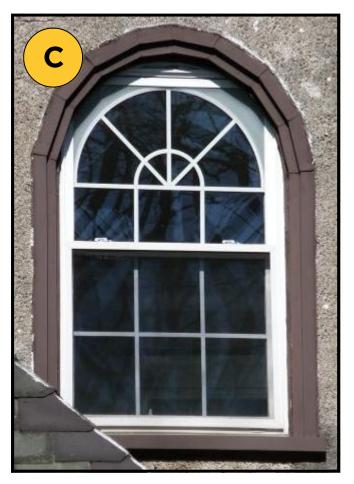
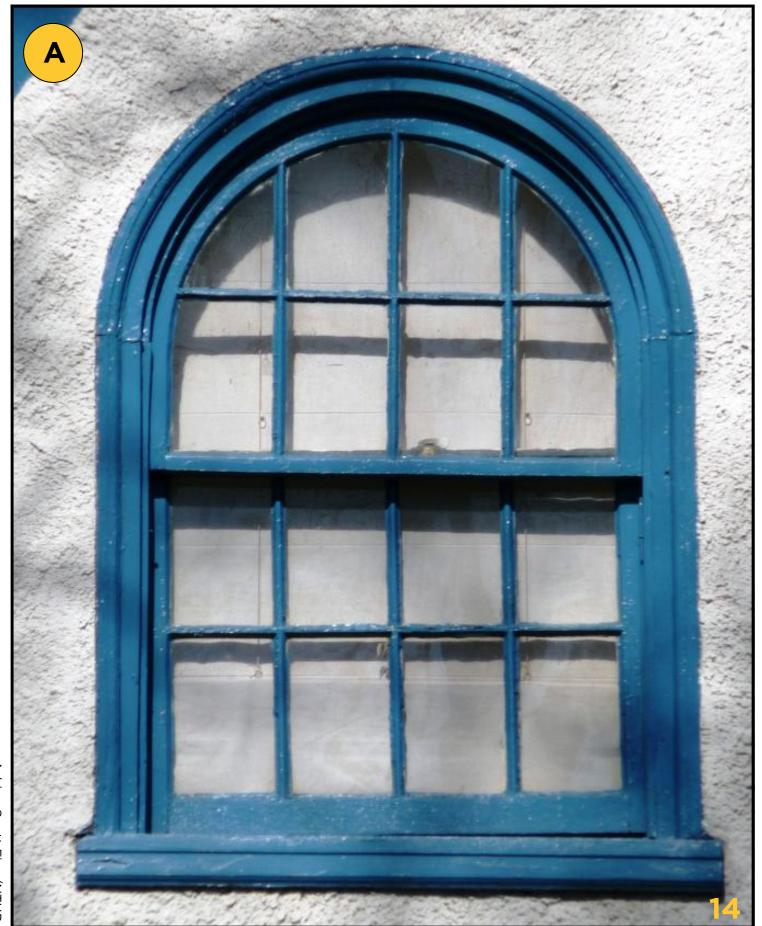
- A This eight-over-eight double-hung sash window with wood casing and sill is a common feature on houses in this neighborhood.
- B This replacement window attempts to replicate details of the original. However, it is not a true divided-light, the casing is wrapped in aluminum and the upper sash is flat and not round arched.
- C. This replacement tries to look like a round arched window but is instead flat, features a completely different muntin pattern, has casing wrapped in aluminum and is not a true divided-light.

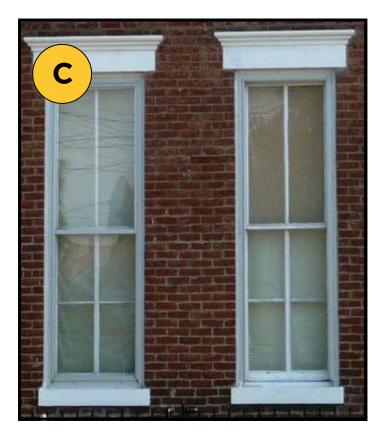
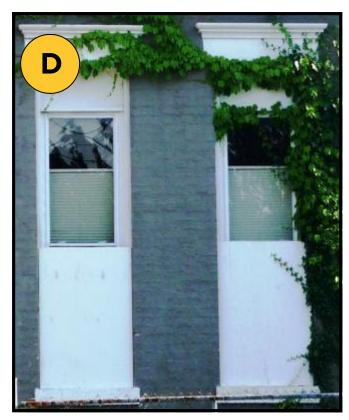
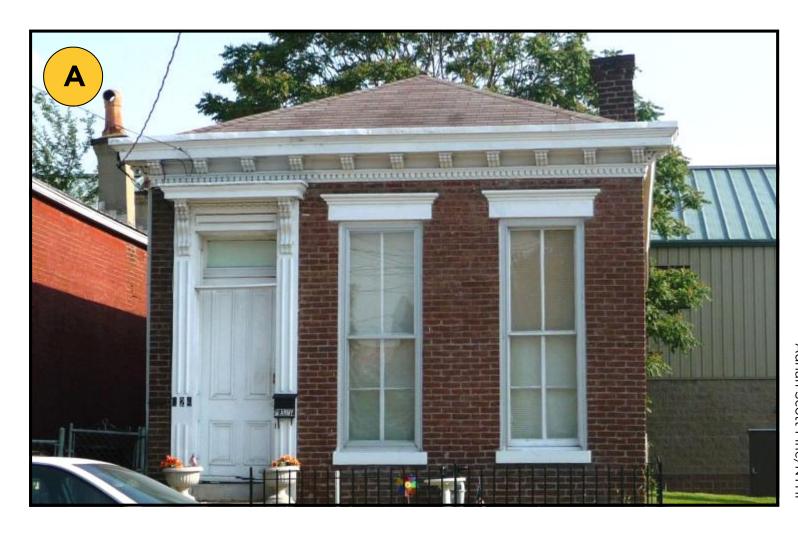
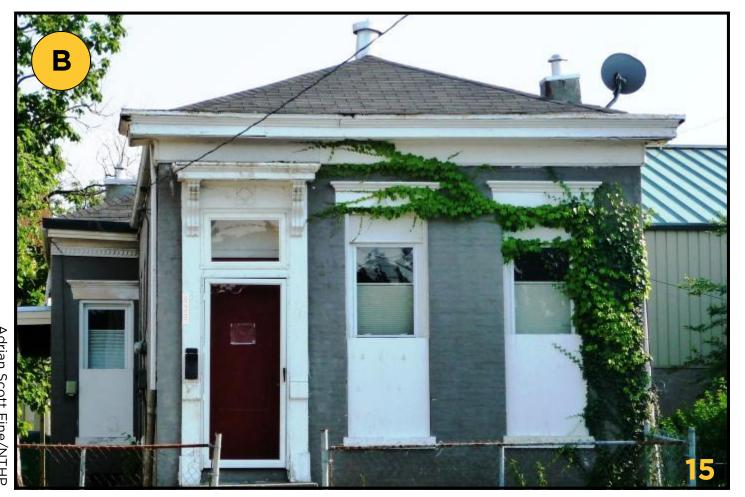
- A, B Two simple Shotgun style homes that were once nearly identical, to each other, and throughout the neighborhood.
- C Original two-over-two double-hung windows are a very prominent feature of these homes, directly relating to the size of the main entrance.
- D. The original windows were replaced, the openings reduced, and stock windows installed that are no longer in scale to the proportions of the house.

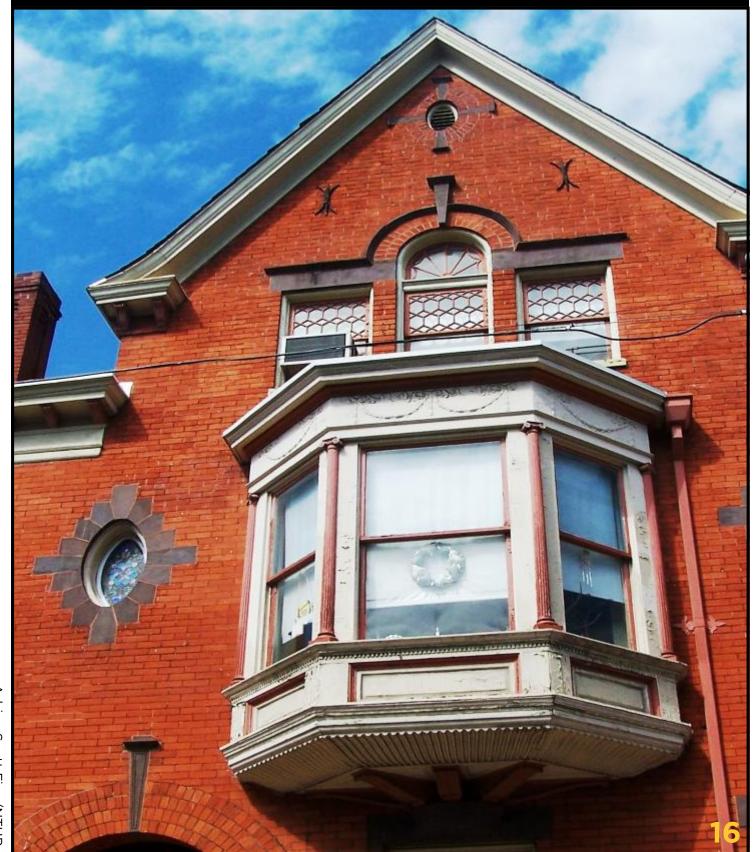
Early 20th century Queen Anne style house Original windows help define the character of older buildings
