CHARLOTTE-MECKLENBURG UTILITIES CHARLOTTE, NORTH CAROLINA

REHABILITATION OF EXISTING MANHOLES
(PAGE 2 OF 2)

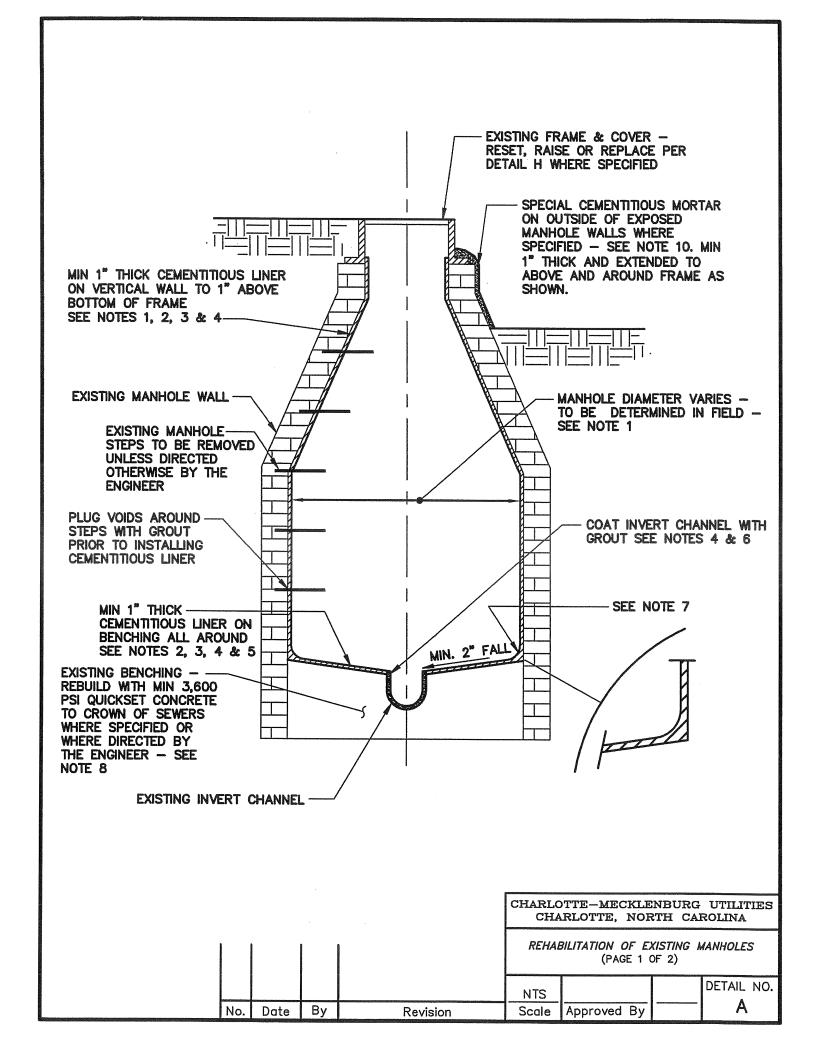
- MANHOLE SHOWN IS A TYPICAL SHAPE. HOWEVER, MANHOLE SHAPES WILL VARY. CONTRACTOR SHALL DETERMINE ACTUAL SHAPE. UNIT PRICES BID SHALL COVER ANY SHAPE.
- BID ITEMS ARE INCLUDED FOR COATING EXISTING 4-FOOT, 5-FOOT, AND 6-FOOT DIAMETER MANHOLES WITH ANY SPECIFIED MATERIAL AND WITH HYDROGEN—SULFIDE RESISTANT MATERIAL. THE ENGINEER WILL SPECIFY THE REQUIRED MATERIAL FOR EACH MANHOLE.

- 3. CEMENTITIOUS LINER SHALL NOT BE INSTALLED UNTIL ALL MAIN SEWER, SERVICE LATERAL WORK WITHIN THE MANHOLE, AND OTHER MANHOLE REHABILITATION WORK IS COMPLETED.

- 5. PROVIDE ADDITIONAL CEMENTITIOUS MATERIAL AS NECESSARY TO PROVIDE A MINIMUM 2" FALL FROM THE MANHOLE WALL TO THE INVERT CHANNEL. ANY AND ALL ADDITIONAL CEMENTITIOUS MATERIAL REQUIRED TO PROVIDE THE 2" FALL SHALL BE INCIDENTAL TO THE WORK AND SHALL BE INCLUDED IN THE UNIT PRICE BID FOR THE CEMENTITIOUS COATING. THE CONTRACTOR IS ADVISED THAT MOST OF THE EXISTING BENCHES ARE FLAT. PROVIDE CHANNEL IN BENCHING FOR SEWERS ENTERING MANHOLES ABOVE BENCHING. CHANNEL TO PROVIDE SMOOTH TRANSITION TO MAIN INVERT CHANNEL.

- 6. COAT INVERT CHANNELS WITH A QUICKSET NON-SHRINK GROUT TO PROVIDE A CONSTANT SLOPE BETWEEN INLET AND OUTLET SEWERS WHEN SPECIFIED/REQUIRED BY THE ENGINEER. PROVIDE ADDITIONAL MATERIAL AS NECESSARY TO PROVIDE A UNIFORM INVERT CHANNEL THROUGH THE MANHOLE. THE WIDTH OF THE UNIFORM CHANNEL SHALL BE EQUAL TO THE INCOMING AND OUTGOING PIPE DIAMETERS. THE FINISHED CHANNEL SHALL BE SMOOTH AND FREE OF BURRS THAT WILL CATCH TOILET PAPER, DEBRIS, RAGS, ETC. SEE NOTE 8.
