Goose Creek Watershed Management Plan Addendum Final Report for Fiscal Year 2022

Prepared by Mecklenburg County Water Quality Pollution Prevention Program July 27, 2022

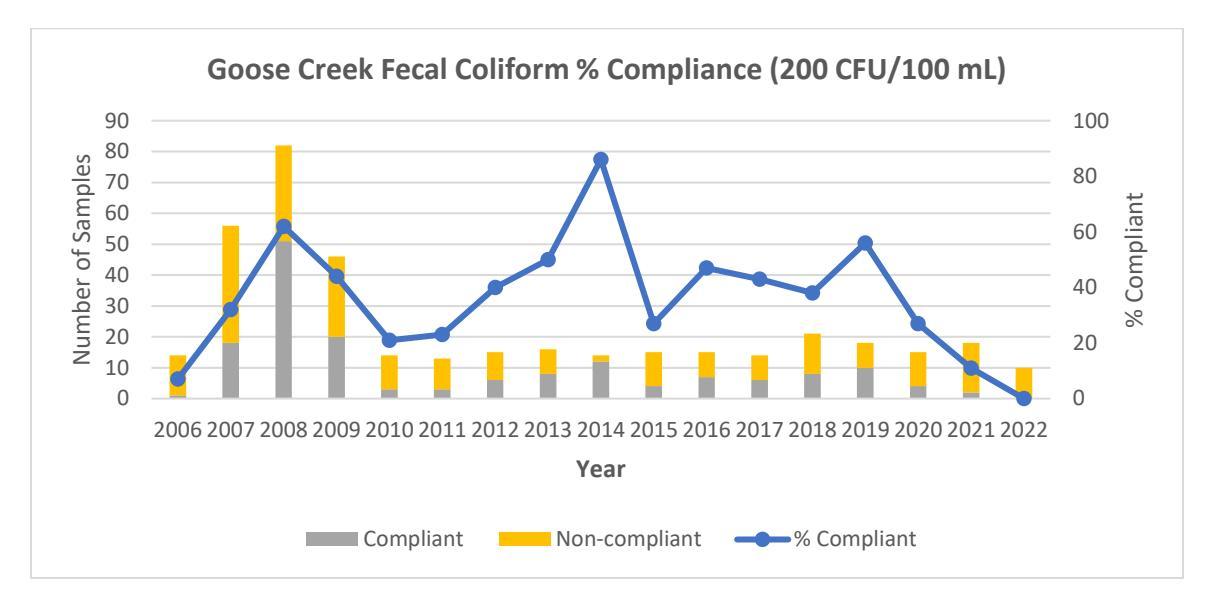
Figure 2 – Fecal Coliform Compliance

Mean fecal coliform levels in Goose Creek exhibited small decreases from 2021 to 2022. Additionally, the percentage of samples complying with applicable fecal coliform standards has decreased over the past several years at 200 CFU/100 ml. However, at a standard of 400 CFU/100 ml the percentage of samples in compliance has been increasing over the past few years. The existing BMPs for these watersheds therefore appear to be effective at identifying and eliminating pollution sources in compliance with TMDL requirements. These BMPs will continue to be implemented in FY2022.

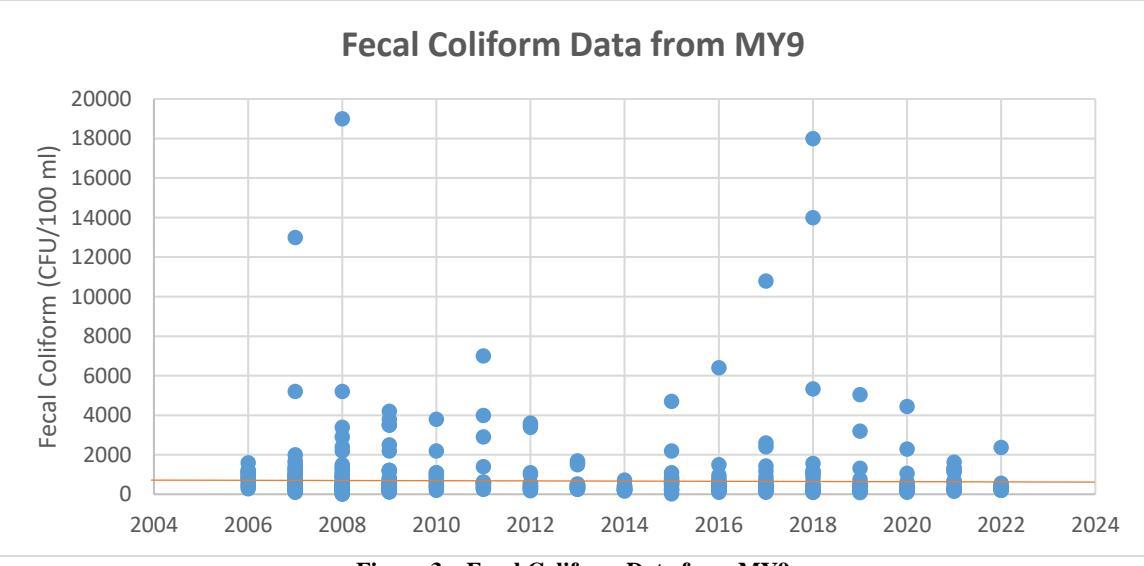
Figure 3 – Fecal Coliform Data from MY9

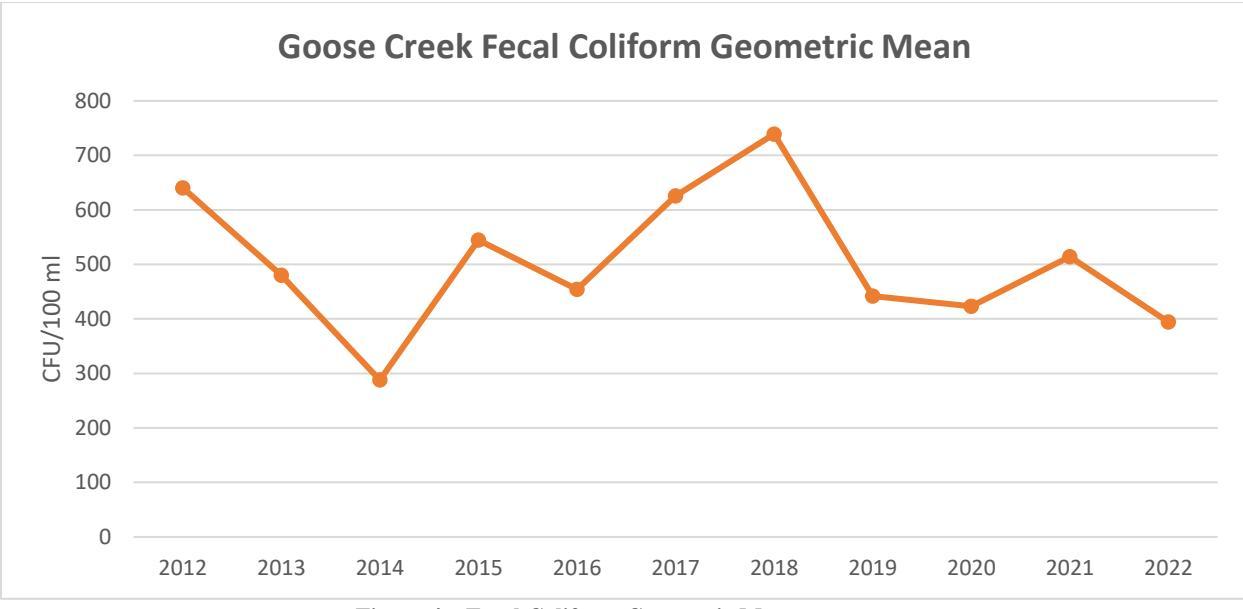
Figure 4 – Fecal Coliform Geometric Mean

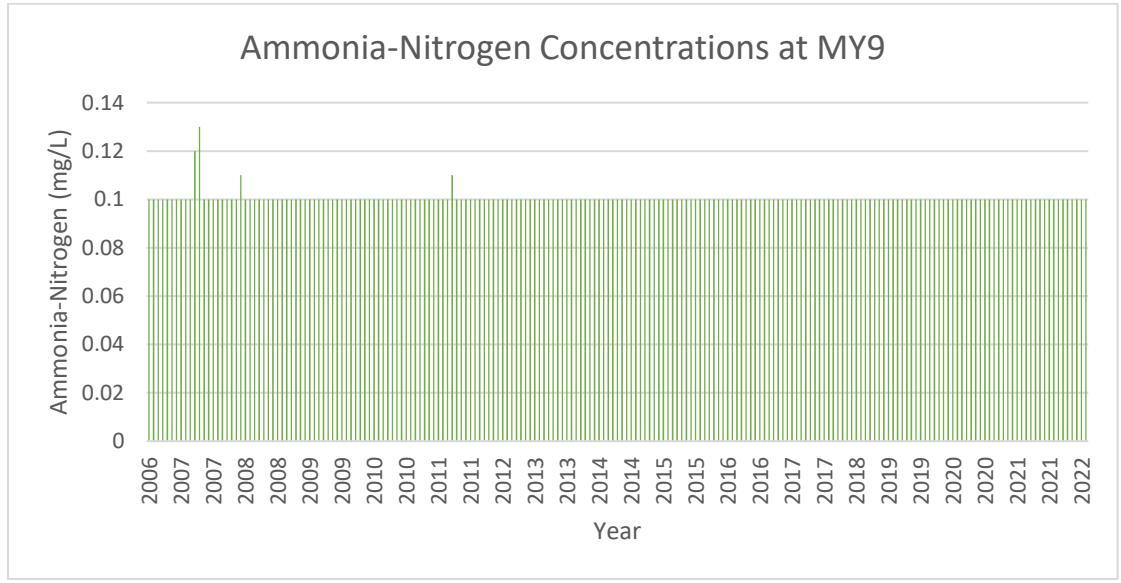
Monthly grab samples are collected at site MY9 and analyzed for a variety of analytical parameters which include ammonia-nitrogen. Figure 5 shows ammonia-nitrogen concentrations recorded at MY9 from July 2006 through June 2022.

Figure 5 – Ammonia-Nitrogen Concentrations from MY9

For this assessment period, there has been no documented exceedances of the chronic or acute water quality biological standard for ammonia at MY9. The laboratory method detection limit (MDL) is 0.1 mg/L, and 98% of the samples collected have been below the MDL.

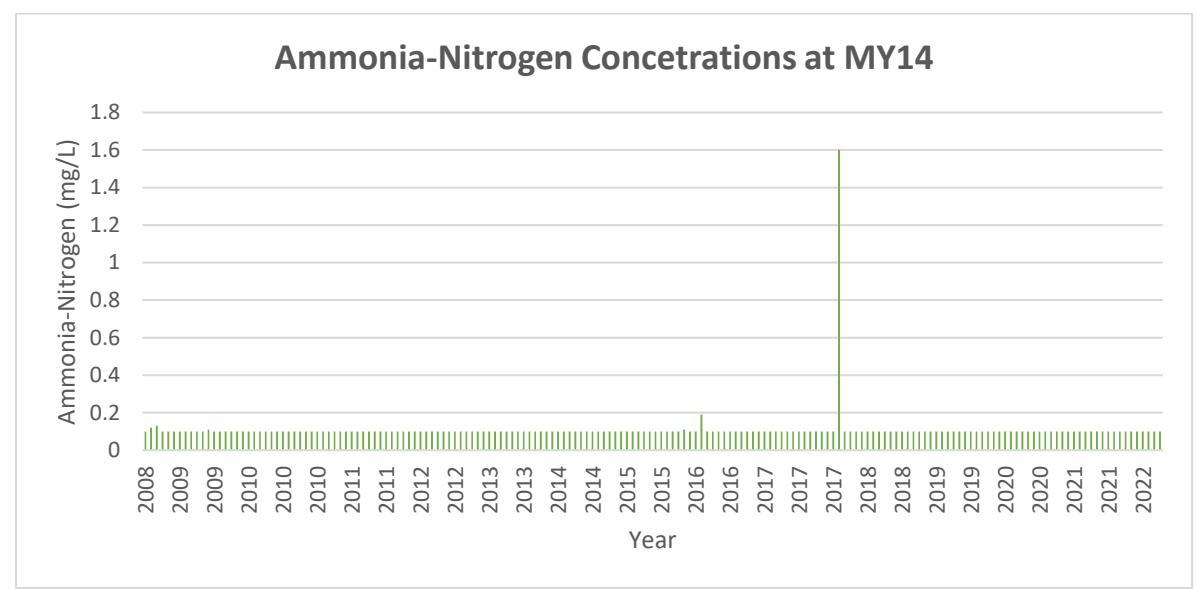
Monthly grab samples are collected at site MY14 and analyzed for a variety of analytical parameters which include ammonia-nitrogen. Figure 6 shows ammonia-nitrogen concentrations recorded at MY14 from August 2008 through June 2022.

Figure 6 – Ammonia-Nitrogen Concentrations from MY14

For this assessment period, there has been no documented exceedances of the acute water quality biological standard for ammonia at MY14. Although there were two single concentrations that exceeded the chronic standard, this would not be considered a violation of the standard since the methodology for calculating the chronic standard requires that samples be collected over a 4-day window and averaged. The laboratory method detection limit (MDL) is 0.1 mg/L, and 99% of the samples collected have been below the MDL.
