Water Quality Recovery Program for the Rocky River Fecal Coliform Total Maximum Daily Load Assessment Unit Number 13-17a

Original: July 2010 Revised: July 2012, December 2014, and August 2015

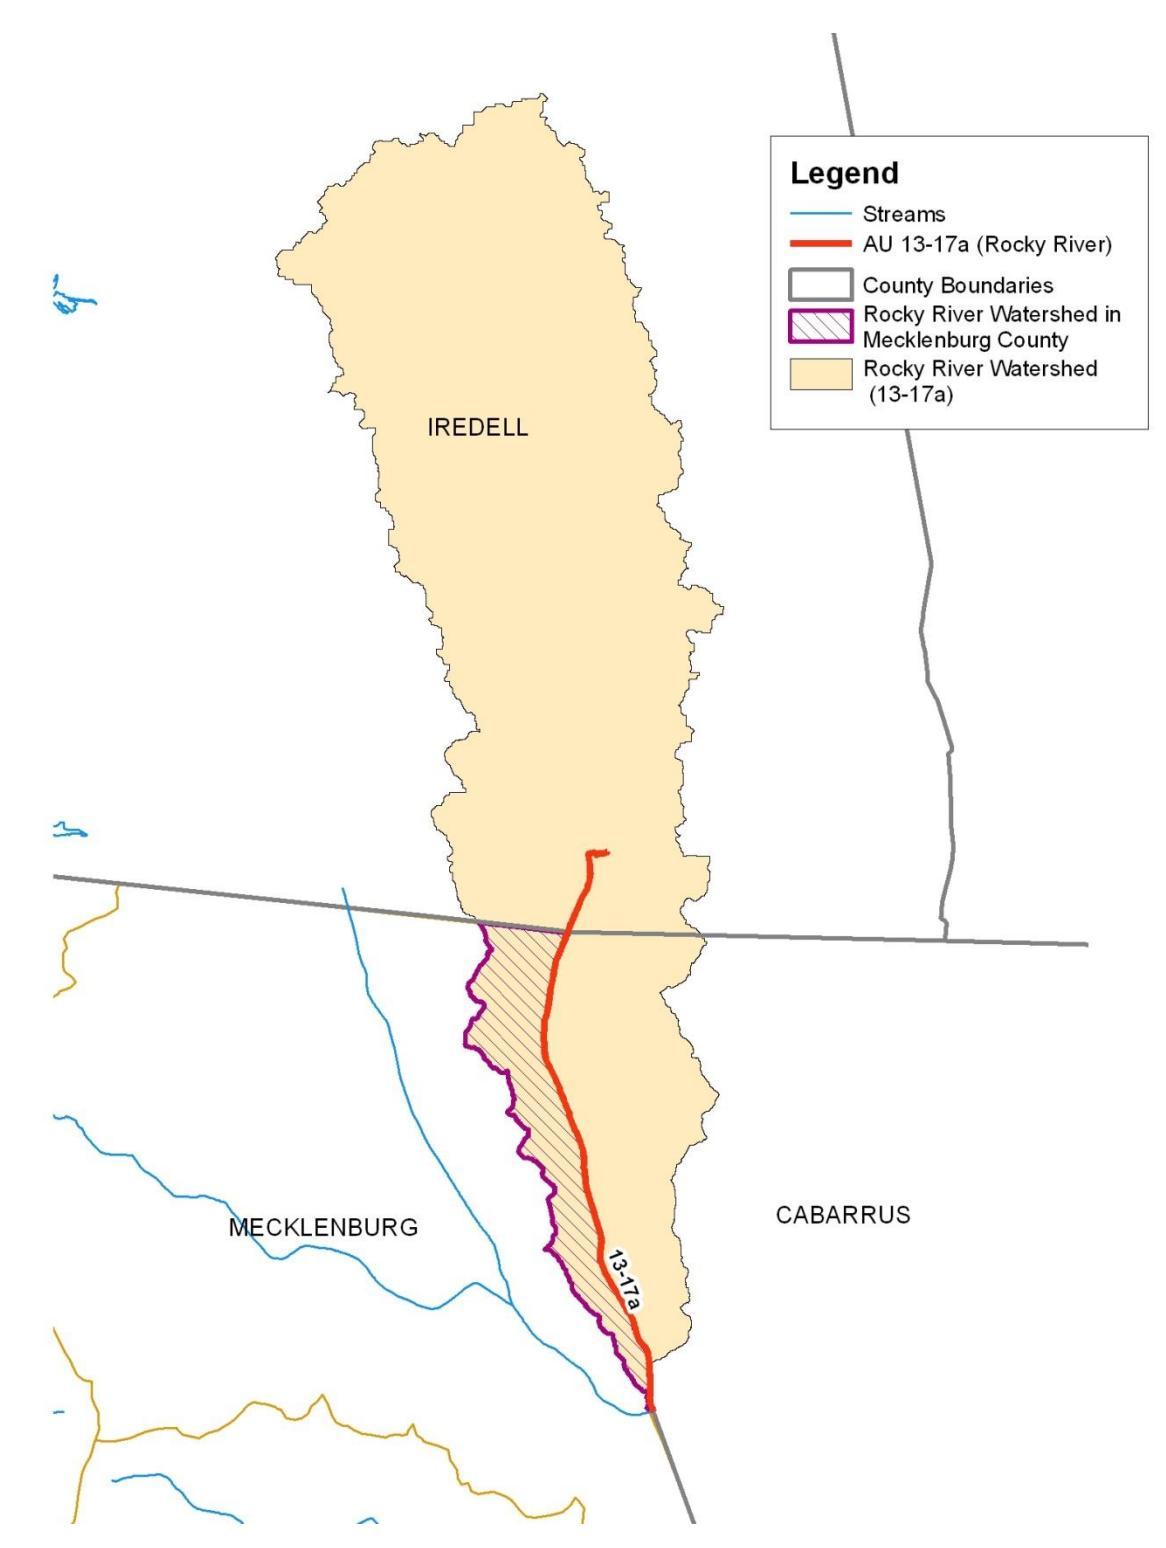
The Rocky River Watershed (Assessment Unit 13-17a) is located in the northeast corner of Mecklenburg County and extends into portions of Iredell and Cabarrus Counties. This Water Quality Recovery Program applies to the Mecklenburg County portion of the watershed as identified in Figure 1. Figure 2 shows the one known storm water outfall in the Rocky River Watershed located in Mecklenburg County as of July 2010. The watershed area is comprised of large, primarily single family residential lots, farms and wooded areas. Table 2 and Figure 3 describe the land uses in the Rocky River Watershed in Mecklenburg County as of July 2010.

Requirement	Schedule
1. Description of the watershed.	Completed (see
	Section A below)
2. Map of the watershed showing streams and outfalls.	Completed (see
	Figure 1 below)

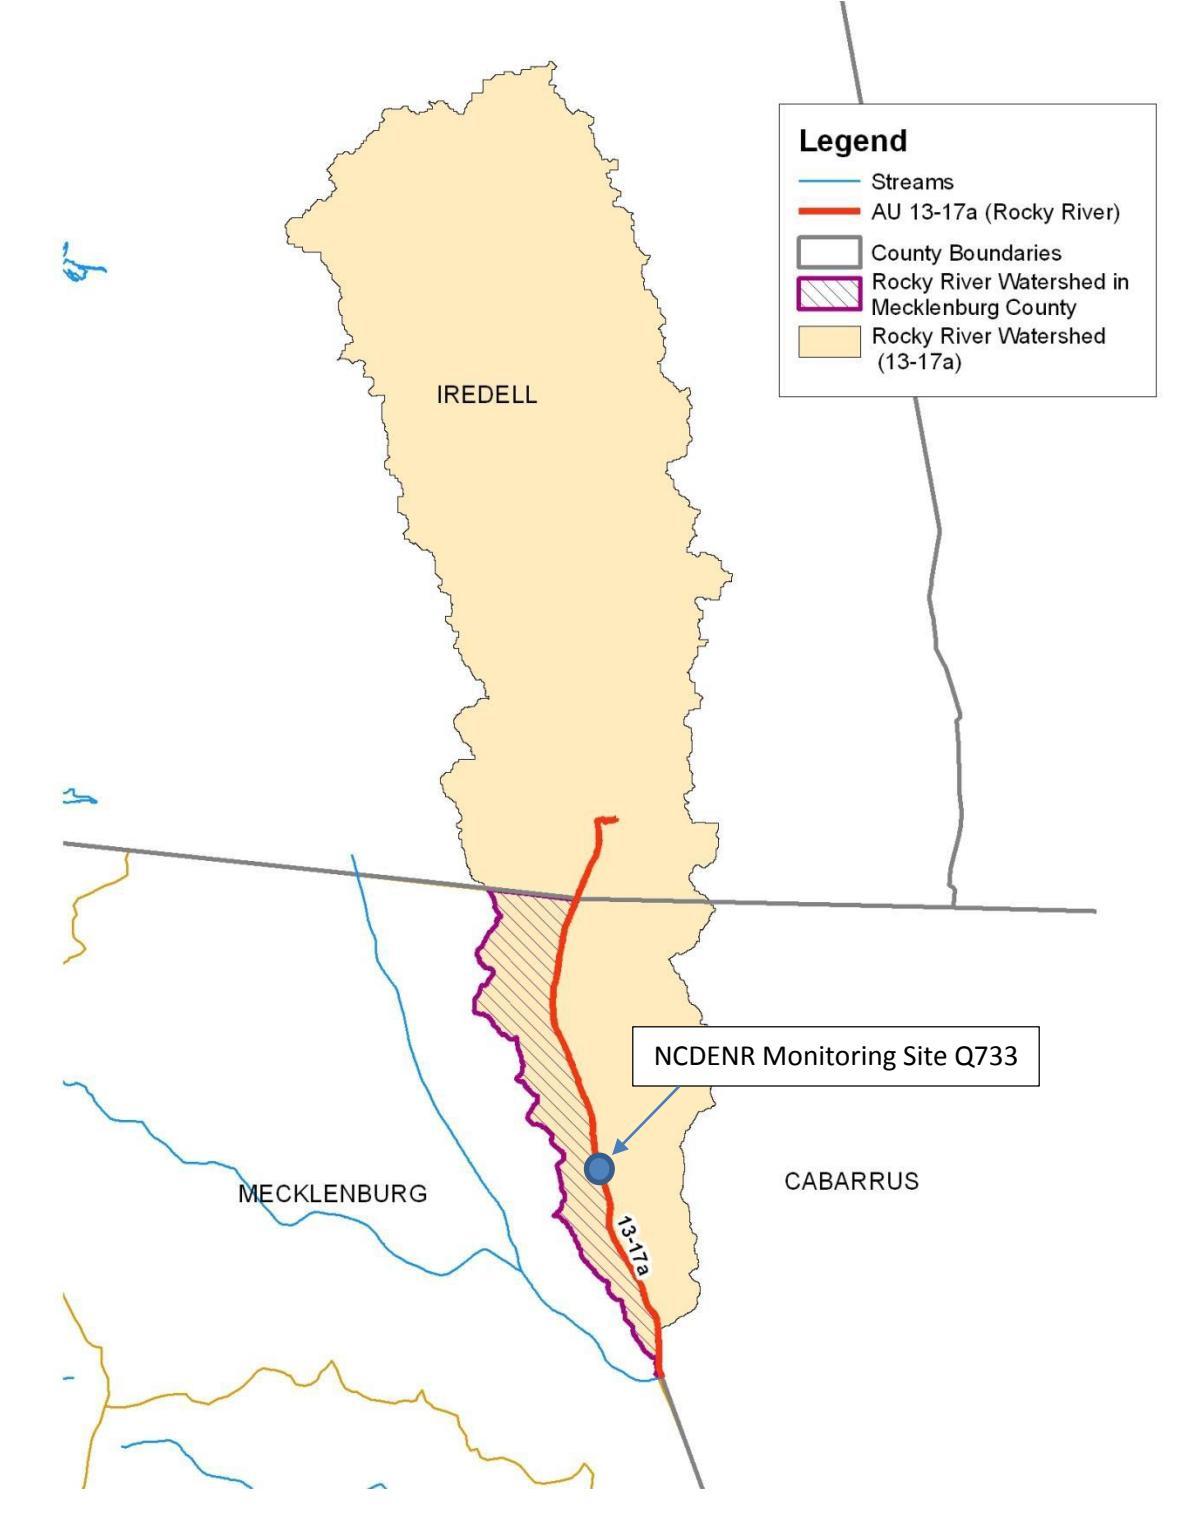
CMSWS does not currently maintain a monitoring site on the Rocky River (AU 13-17a) as explained in Section D. CMSWS has obtained all Fecal Coliform data collected from the Rocky River Watershed (AU 13-17a) by DWQ at monitoring site Q733 located at 35.4749, -80.77948 (see Figure 4). Fecal Coliform data at Q733 begins on July 15, 1970 and continues at various intervals, generally monthly, until October 2, 1986. The Fecal Coliform sampling was restarted on May 2, 1995 and continued monthly through 2014. DWQ was contacted concerning the missing data between October 2, 1986 and May 2, 1995. DWQ verified the Fecal Coliform sampling was not performed during these years. All available Fecal Coliform data from DWQ for Q733 was analyzed to identify trends. A five (5) year rolling average was calculated for violations of the instantaneous Fecal Coliform standard of 400 colonies/100 ml. as shown in Figure 5. A definite downward trend is visible, especially from 1980 through 1985 and again

- 1. NCDENR maintains a monitoring site on the Rocky River. Figure 4 shows the portion of the TMDL watershed within Mecklenburg County along with the existing NCDENR monitoring site #Q733. Additional monitoring on the impaired section of the Rocky River would duplicate the sampling conducted at this location.

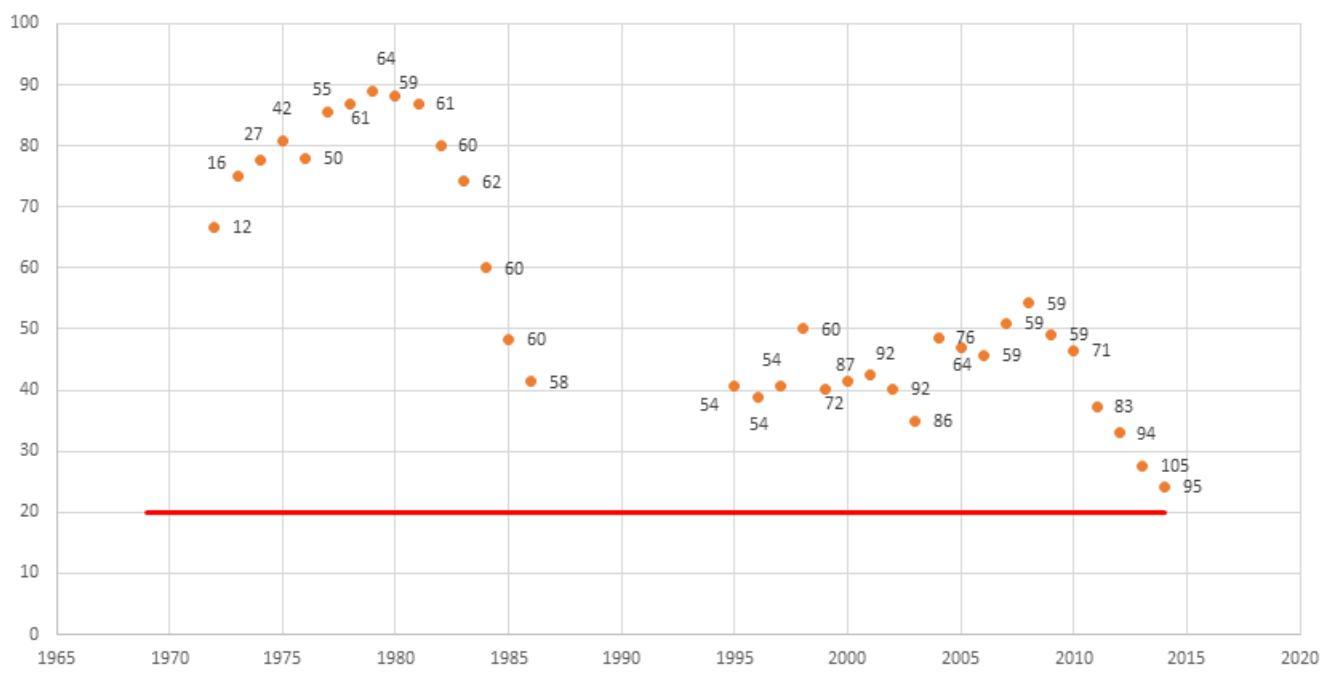
Figure 5: Five (5) Year Average Fecal Coliform Violation Rate at DWQ's Monitoring Site Q733 (number of samples represented in the 5 year average is shown next to the point)

from 2010 through 2014. The geometric mean for Fecal Coliform for 2010-2014 is 248 and for 2011-2014 is 230.

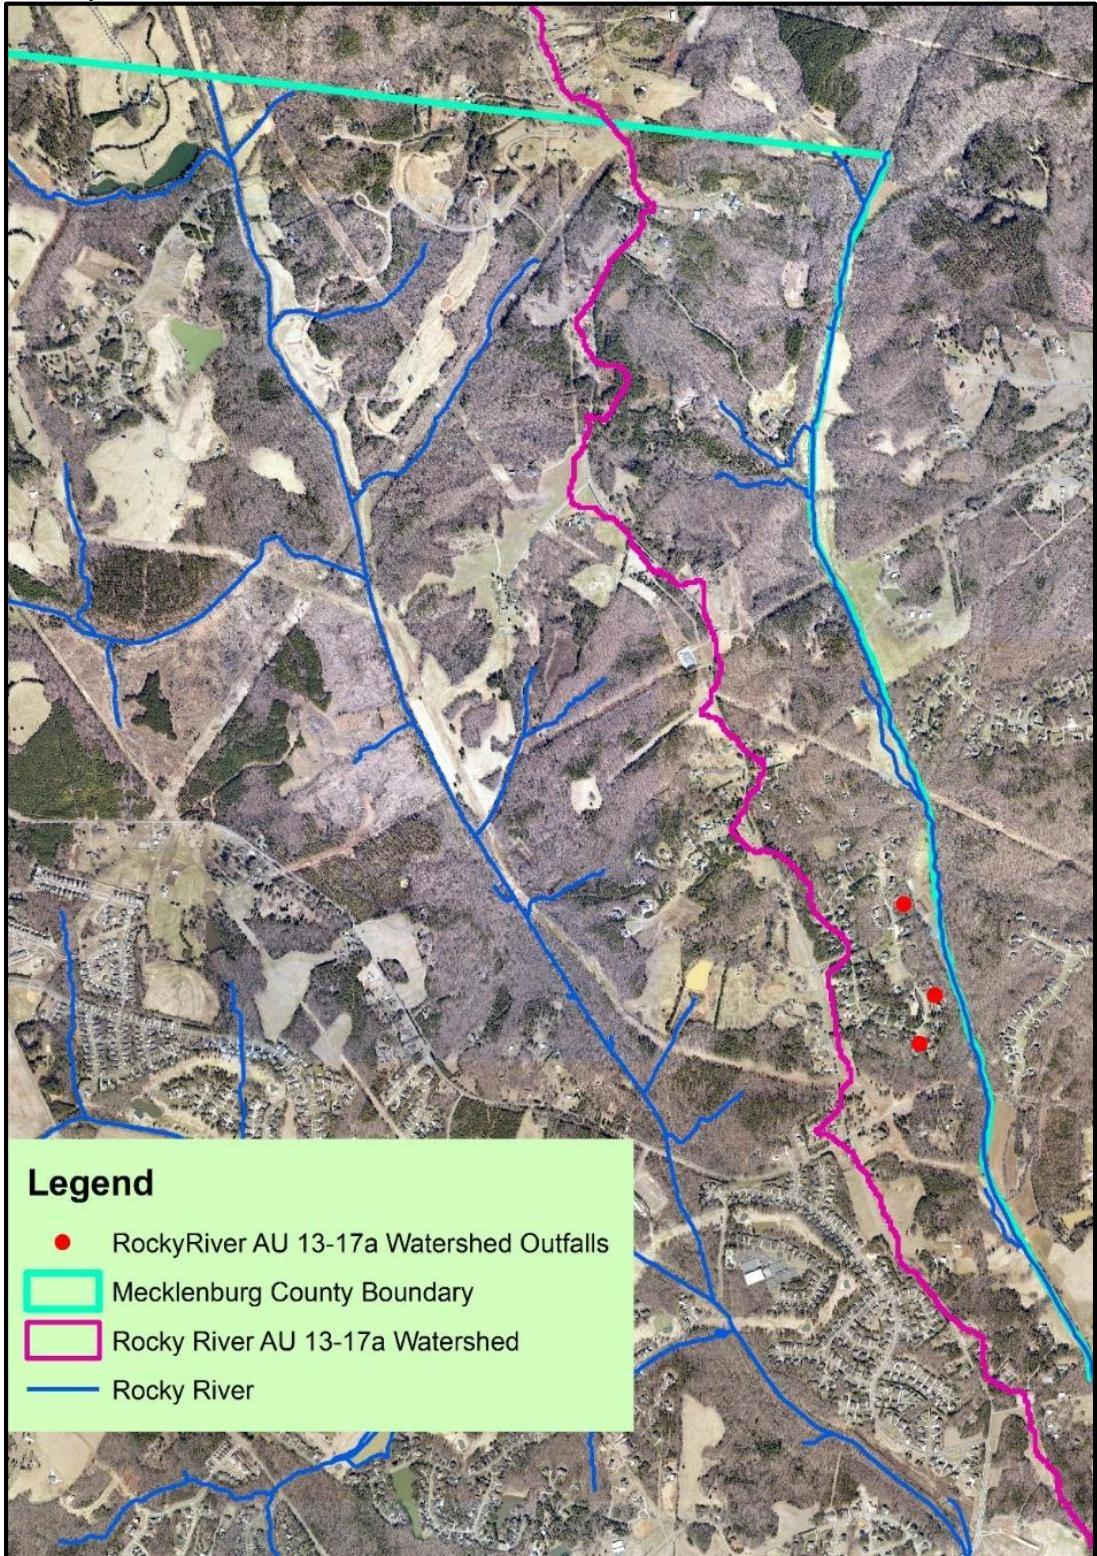
Figure 6: Storm Water Outfalls in the Rocky River Watershed in Mecklenburg County as of January 2015

Watershed Measure	2011	2012	2013	2014	# Increase from FY11	% Increase from FY11
Residential Impervious Cover (acres)	14.22	14.22	14.17	14.19	0.0	0%
Commercial Impervious Cover (acres)	0.33	0.33	0.33	0.33	0.0	0%
Total Impervious Cover (acres)	14.55	14.55	14.5	14.52	0.0	0%
Storm Water Outfalls (number)	1	1	3	3	2.0	200%
